HISTORIC ARCHITECTURE ASSESSMENT REPORT

THE WILLIAM BUTTERS II HOUSE

WILMINGTON HISTORICAL COMMISSION

DECEMBER 4, 2007

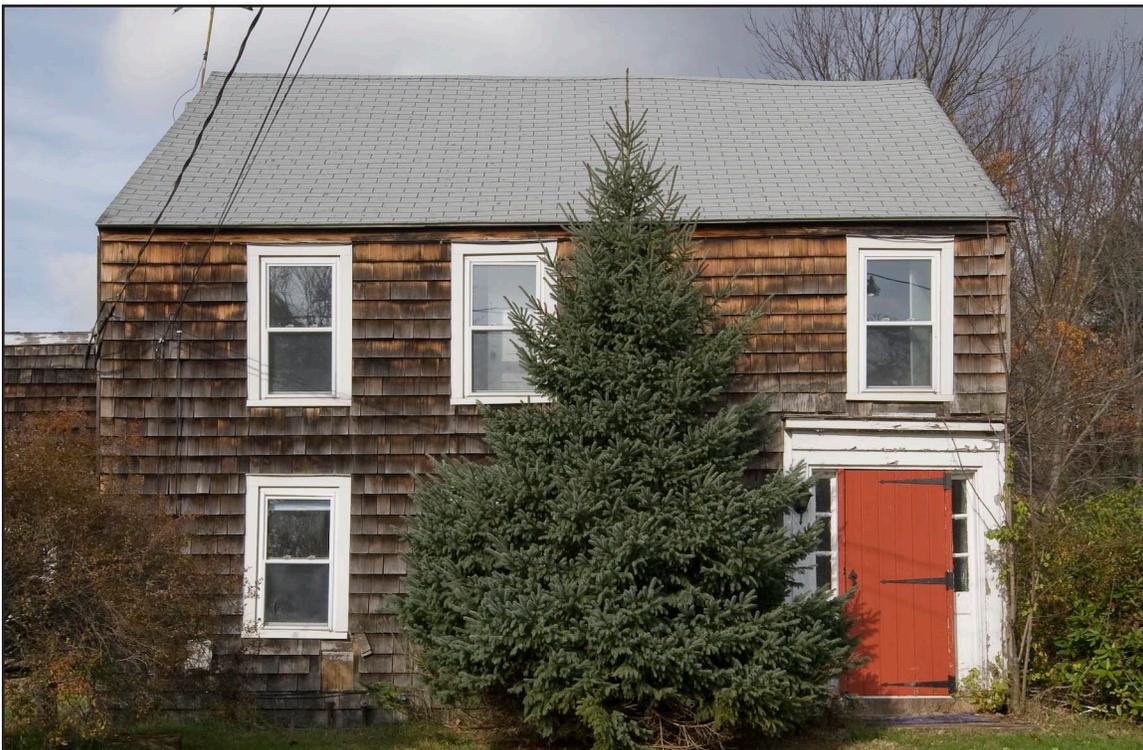
The main front door and sidelights are a stock entry unit installed in the 1970s to replace what was probably a mid-19th century entry of similar design (Photo 2). The pilasters and cornice above the entry were not replaced in the 1970s. They are of a simplified Greek Revival style design and may date to anytime the 1840s and the 1920s. The cornice woodwork currently shows substantial rot under its vinyl covering.

Photo 2: Front (south) facade of main house.

Unless better evidence of the 19th century appearance of the front entry is found, replacements should match the existing elements.

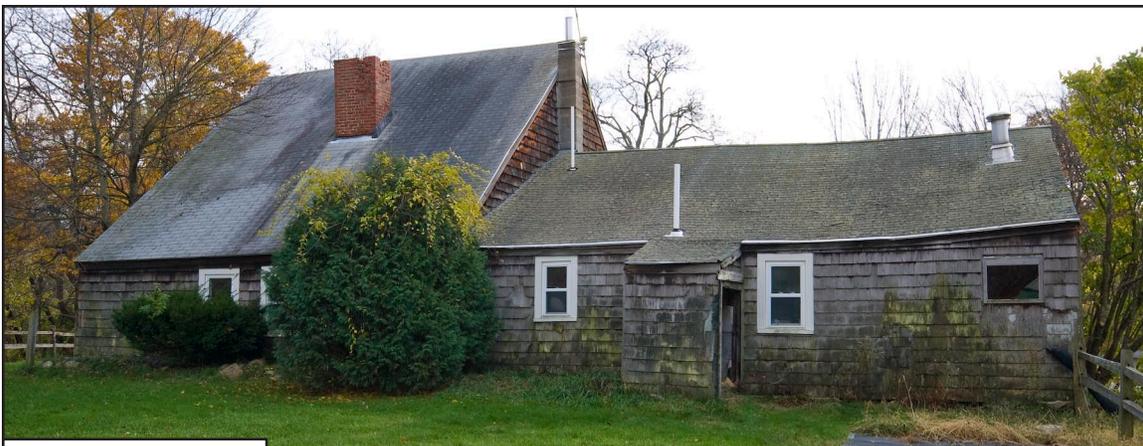
The ell roof exhibits considerable sagging due to structural problems along its rear wall (Photo 4). The span of the lower purlins in the east bay of the roof is excessively long and sagging in this area. These conditions should be corrected in conjunction with reroofing.

Photo 4: Rear facade of main house and ell showing sag in ell roof and green algae growing on shingles from excessive chronic moisture.

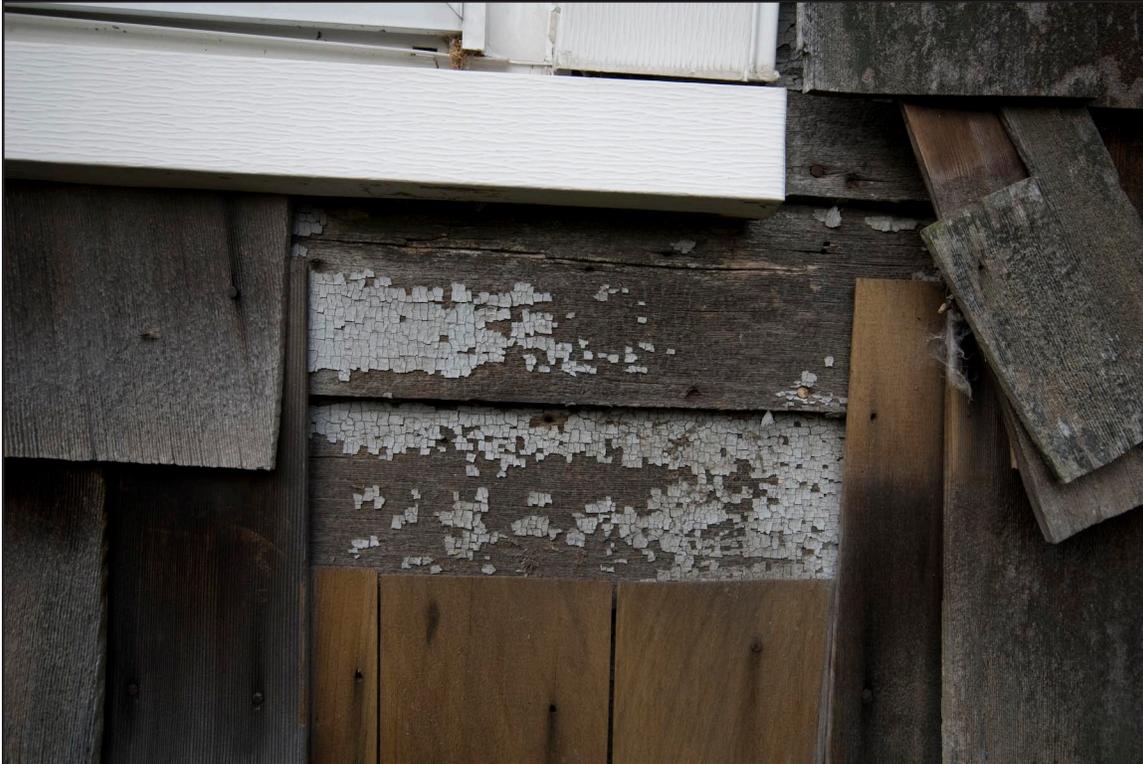
Photo 6: Detail of c. 1840s or later clapboards that remain under the shingles on the front and side facades. The clapboards are too weathered to retain after the shingles are removed. They should be replaced with new clapboards.

The condition of both the shingles and the earlier clapboards beneath them is sufficiently deteriorated to justify their removal to facilitate other needed work to the house. As the 19th century cladding installed on the front and sides when the overhang was framed in was clearly clapboards, new wood clapboards should be installed on these facades as part of the renovation of the house. On the rear facade, examination of the sheathing boards for nailing patterns should be done after the existing siding is removed to determine if they were previously clapboarded. When the clapboards and shingles are removed, the sheathing should be carefully examined and documented with photographs for evidence of the original windows and other early features.

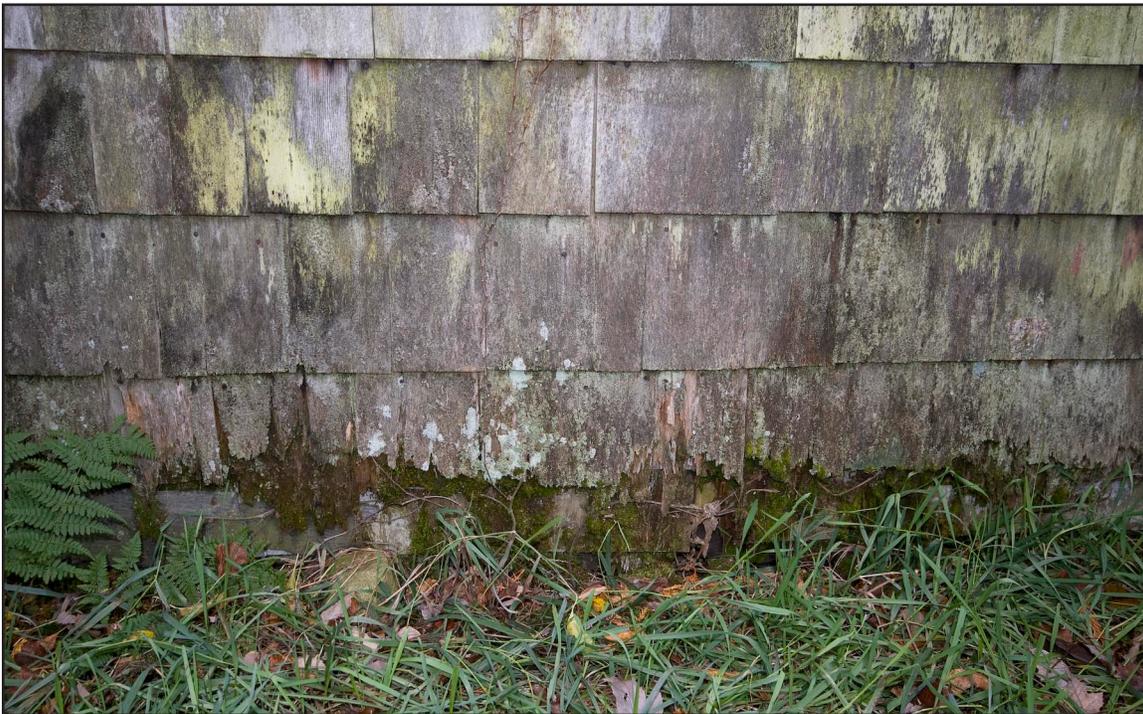
On the rear facade a small area of shingles was removed at the base of the house to evaluate the substrate and the rear sill (Photo 7). The earlier layer of shingles was installed over building paper and therefore also dated to the late 19th or early 20th century. The sheathing boards under it were intact but had surface damage from past insect infestations.

The rear walls of the leanto and ell have moved noticeably outward at their bases, which is usually caused by extensive rot and rotation of the sills. The lower courses of shingles are rotting and growing green algae from chronic dampness caused by a combination of the lack of gutters, dense plant growth against the house, and the high grade of the soil along the rear wall (Photo 7).

Photo 7: Detail of typical poor condition of shingles on the rear facade. The chronic moisture at the base of the building has caused the bottom courses to rot and grow moss. The grade is at or above the bottom course of shingles.

All the trees and shrubs within 5'-10' of the house should be removed, and the soil around the foundation cut back as much as possible to get the grade below the level of the sills.

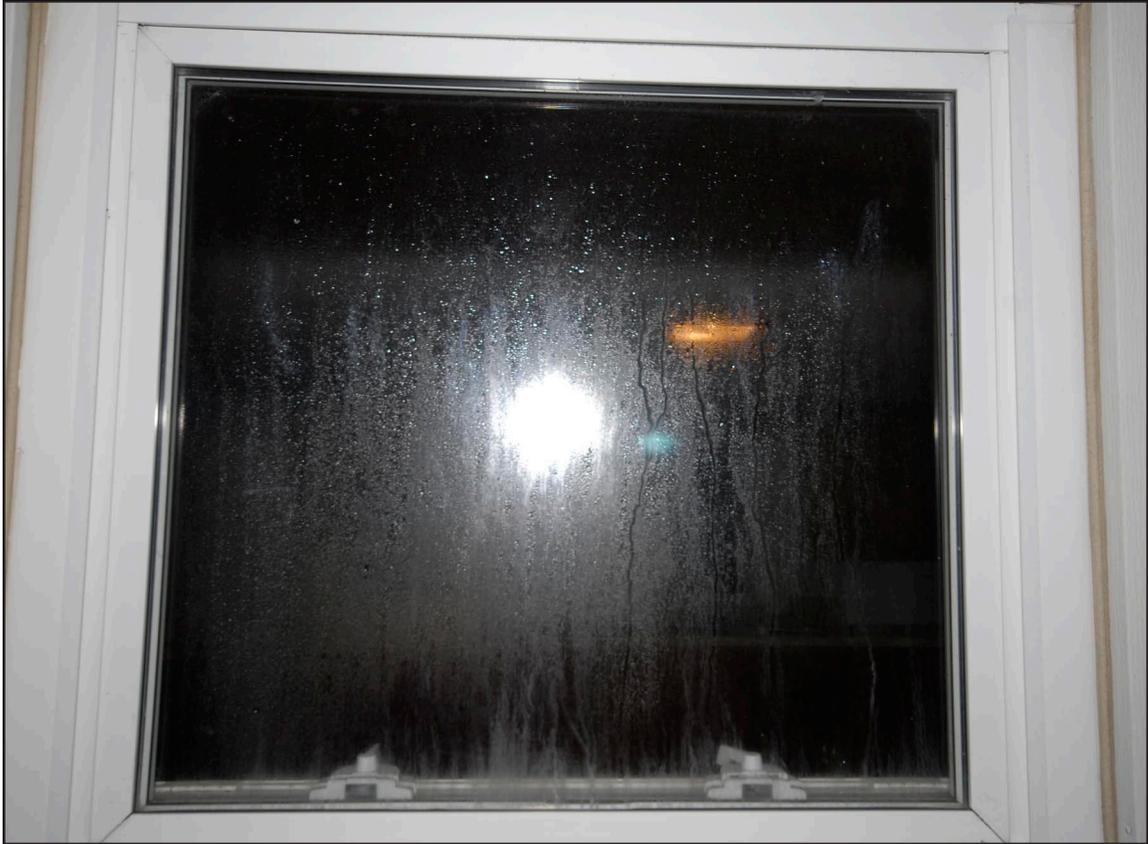
The seals of the double glazing have failed in virtually of the replacement sash causing them to fog over in the cavity between the panes of glass (Photo 8). Historic preservation aside, this makes these sash useless because all the glazing would need to be replaced to make them functional. The vinyl cladding was pried away from the sill and lower casing on one of the first floor front windows. The casing was deeply weathered and the sill so rotted that it nearly fell off (Photo 9).

Photo 8: Typical condition of existing vinyl sash with moisture trapped between the panes of glass due to the failure of the seal of the insulated glass.

While the poor condition of the frame examined may not be universal to all the windows, it should be assumed that all the vinyl sash and their wood frames should be replaced unless further examination reveals that a significant number of window frames remain sound.

The replacement windows should match the size of the existing frames (not the size of the vinyl sash) and have wood sills matching the 2" thickness of the existing 1840s window sills. Based on the few available historic photographs, the configuration should be 6/6. Ideally they should be single glazed wood sash with storm windows, but energy considerations may dictate double glazing. In that case windows having fully three dimensional external muntins with a profile similar to traditional putty glazing should be used rather than the type with thin muntins between the glass or on the interior side only.

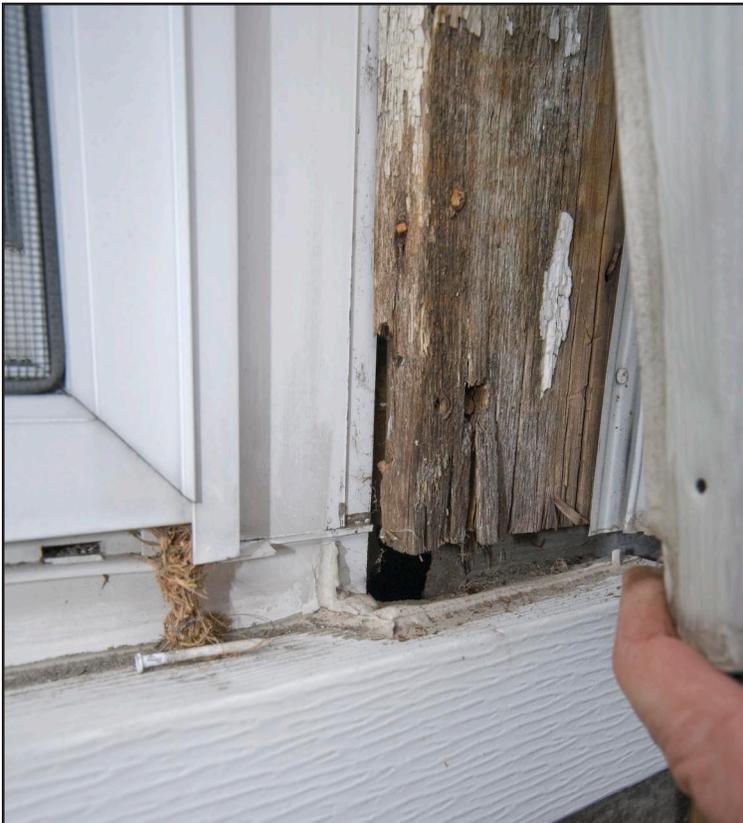
Photo 9: Detail front facade first floor window showing weathered condition of wood window trim under the vinyl cladding. The sill on this window was so loose it nearly fell off.

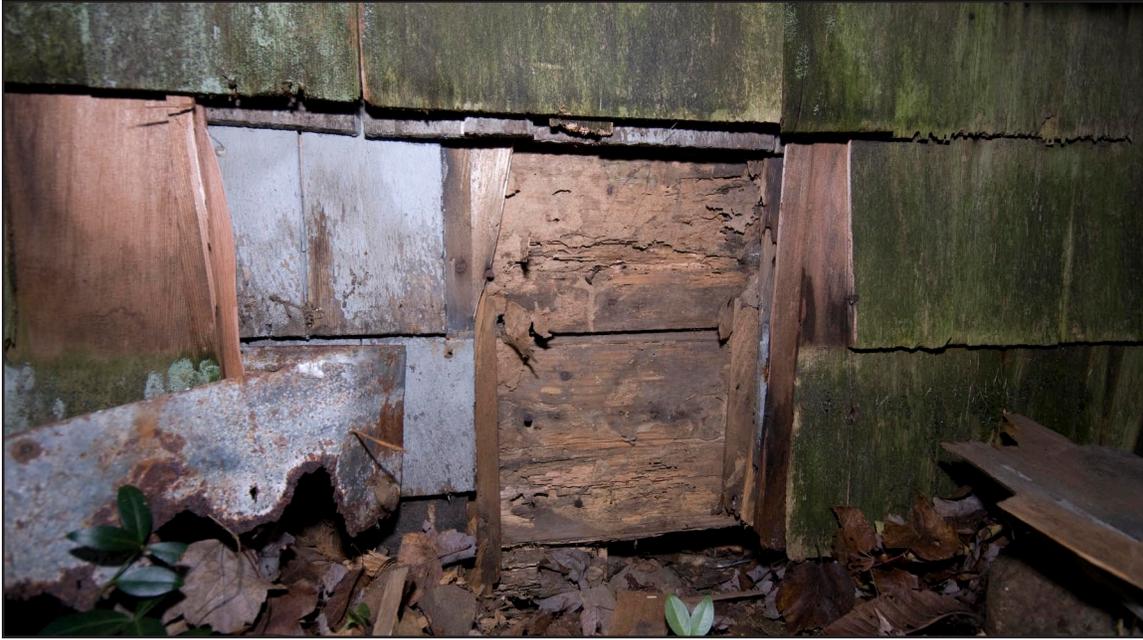
A small section of the rear wall was opened up behind the northeast corner of the kitchen to check the condition of the sill and rear leanto chimney post (Photo 10). The lower few inches of sheathing beneath the shingles was literally buried in the soil and had rotted away. The sill had completely disappeared and the remains of the chimney post was limited to some modern studs ending on a gravelly foundation. A section of both what appears to be the sill and the roof plate is visible where the small former rear entry meets the rear wall of the ell. Both the sill and roof plate were substantially rotted.

Photo 10: Detail of earlier wood shingles and sheathing uncovered at rear of main house behind the north-west corner of the leanto kitchen. The sheathing has old insect damage. There was no sill apparent behind the sheathing, and the top of the foundation was at grade.

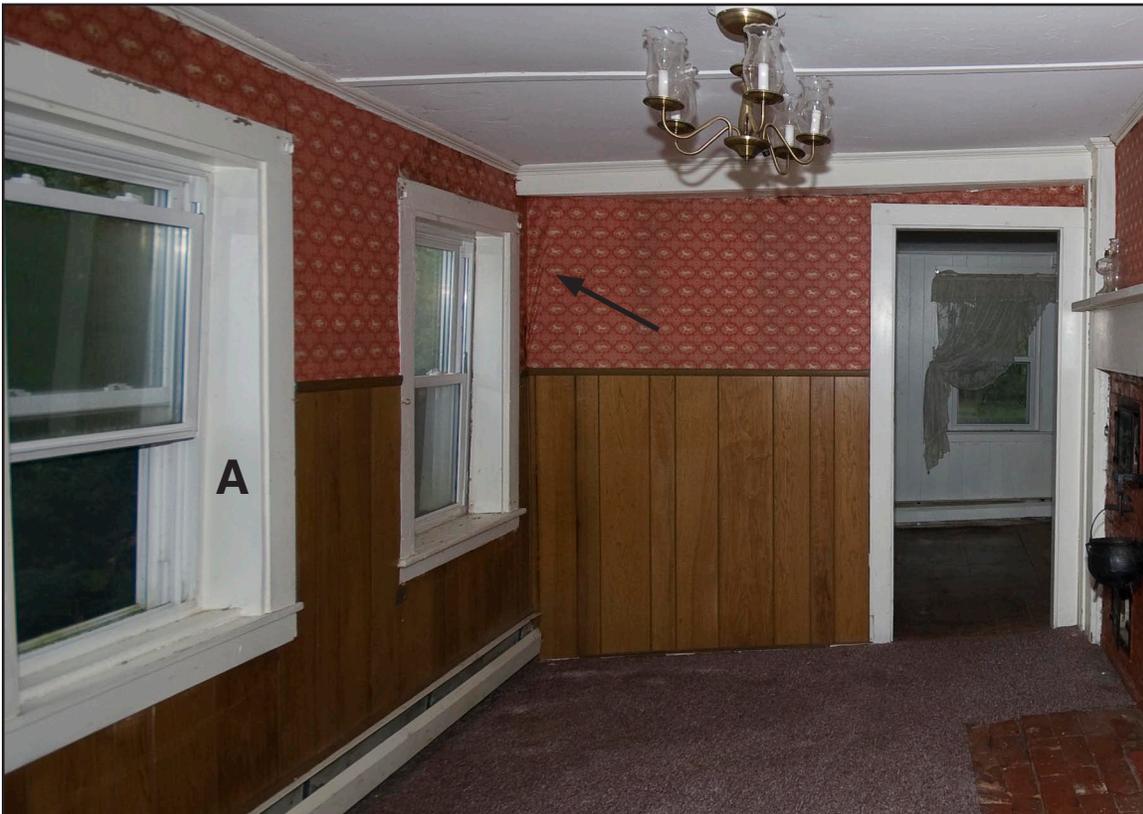
Photo 11: Rear (north) wall of leanto kitchen showing where a new 1970s rear wall was shimmed out from the original wall to make it appear plumb. The extent that the base of the wall rotated out is apparent in the window jambs (A) where the sash are in the plane of the old exterior wall. Also note the downward slope of the ceiling and floor in relation to the level line of the wallpaper on the far wall. The wrinkling of the wallpaper in the corner (arrow) indicates the rear wall has continued to sink since the wallpaper was installed in the 1970s or 80s.

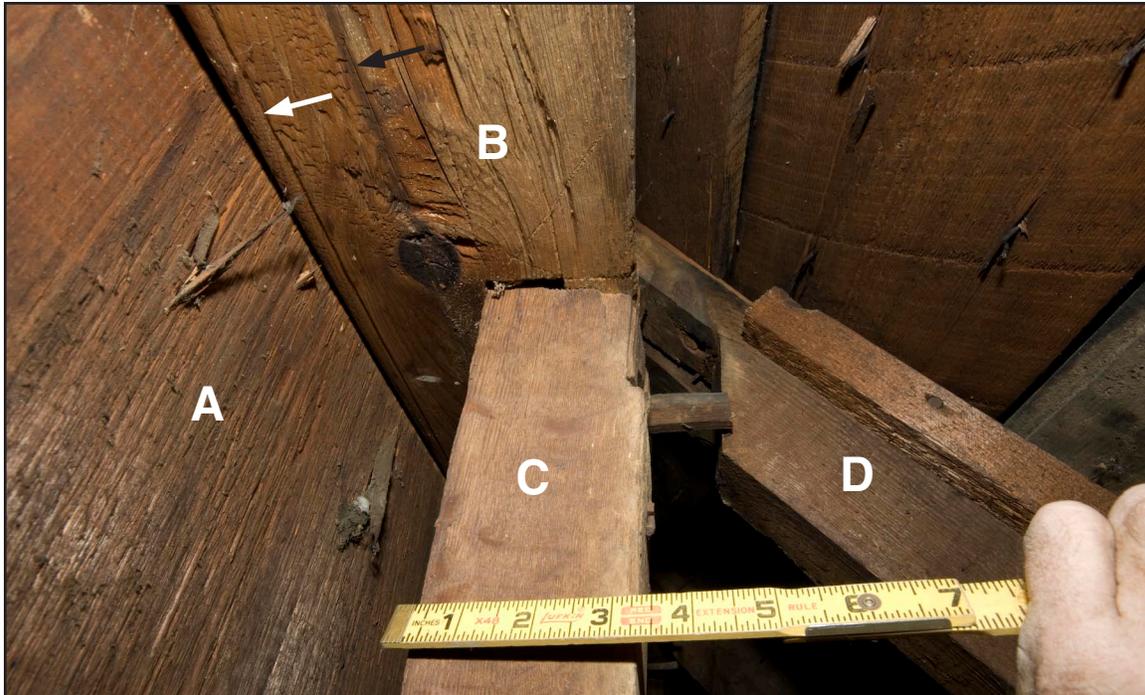
As discussed in the section below on the leanto attic, the condition of the rear leanto wall has caused the leanto roof rafters to pull out of their joints at the main roof plate (Photos 31, 34). The similar conditions at the rear of the ell are likely responsible for the extensive visible sagging of the ell roof.

Photo 31: Framing in leanto attic behind feather edged sheathing shown in photo 30. "A" is the backside of the sheathing. "B" marks the rear parlor chamber girting (functions as a roof plate). The sheathing is nailed to its front face and covers the bead in its bottom edge (white arrow) that would have originally been exposed to view. The original chamber sheathing was likely horizontal boards nailed to stud "C". The dark line (black arrow) likely indicates where the face of original sheathing met the girting. "D" is an original leanto roof rafter that has slipped about 2" back from the girting due to the settlement of the leanto rear wall and sill.

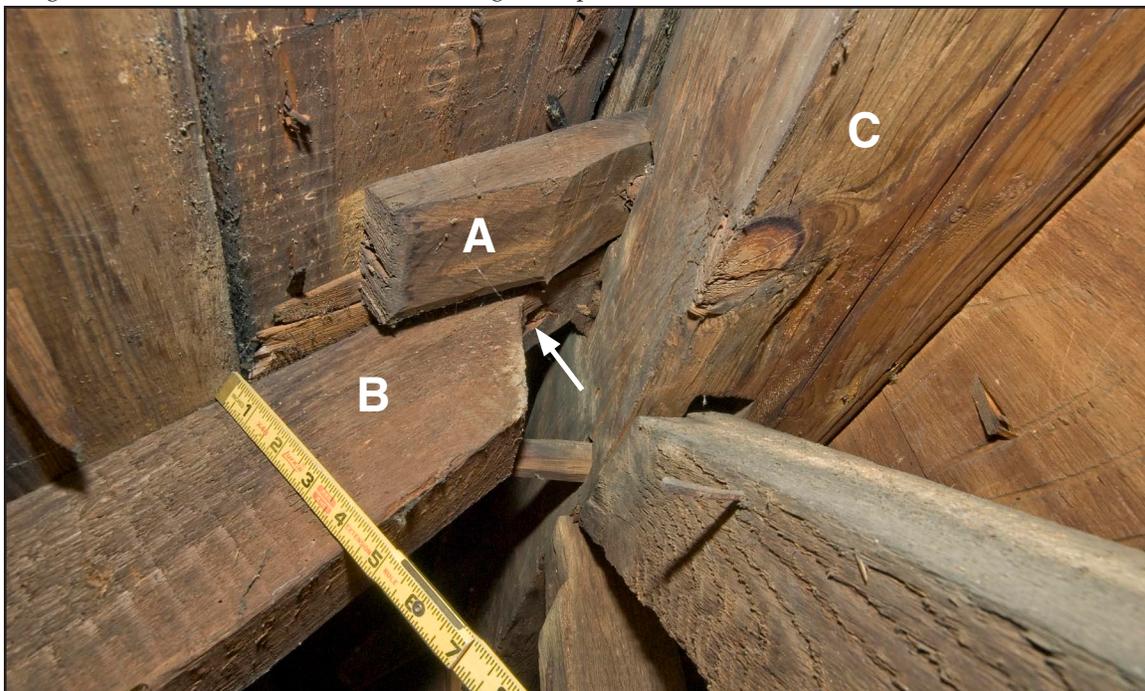
Photo 34: Area marked by the circle in Photo 33 showing details of the rafter joints. "A" marks the projecting tail of a main roof common rafter with bird's mouth joint. "B" marks a leanto rafter that has slipped about 2" back from its original position. Its projecting tenon still sits on the roof plate (C), but the peg securing it in place has sheared off. The arrow marks the hole in the rafter tenon for the peg.

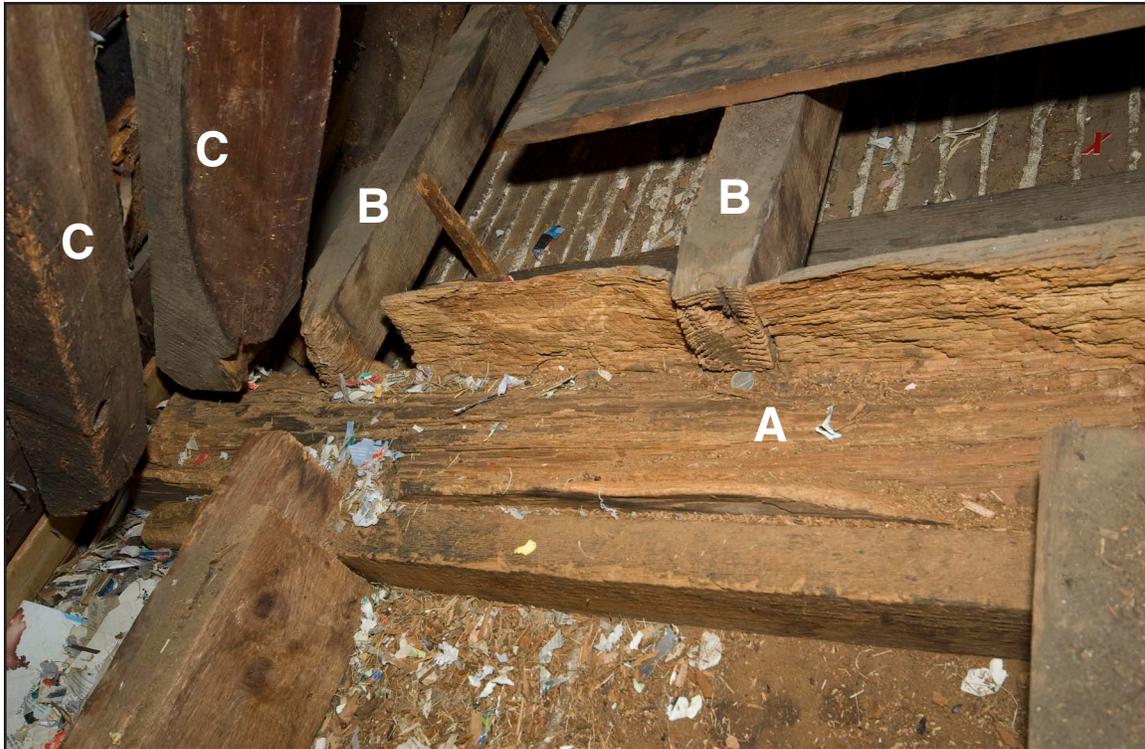
Photo 39: Original attic chimney tie beam (A) showing extensive past rot and insect damage at its south (front) end. The most extensively damaged material has been removed. As the beam is 9" deep, there is still 5" of sound wood left, and the floor loads on it are fairly small. However, the bearing for the floor joists on the far side (B) is minimal, and the roof rafters (C) are floating. The near side joists are supported on a ledger.

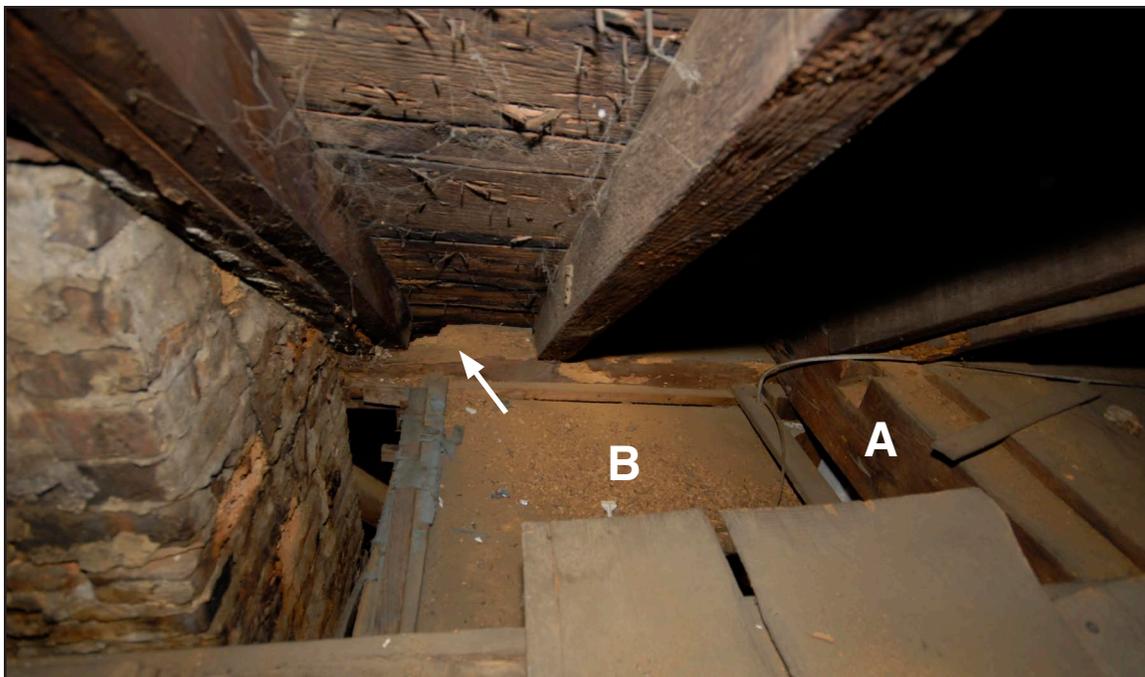
Photo 40: Leanto roof plate at north side of main attic showing rot and insect damage adjacent to the chimney (Arrow). "A" marks the north (rear) end of the attic chimney tie beam shown in photo 39 above. The base of the original rafter that sits on it has severe old insect damage and has reinforced with an added sister rafter. "B" marks the ceiling of closet 203A in the northeast chamber.

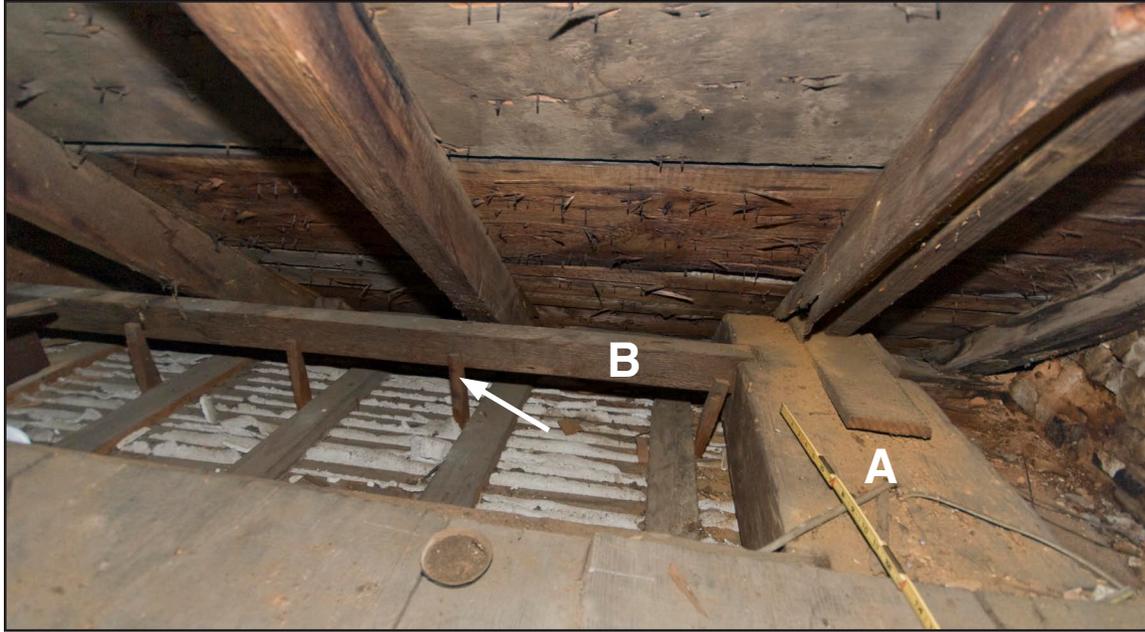
Photo 41: Rear of attic at parlor center tie beam (i.e., summer tie beam) marked "A" showing insect damage to rafter that sits on the beam, and a typical original joist (B) with wood hangers (arrow) added in the 1840s to carry the current c. 1840s parlor chamber ceiling. The floor framing appears to have originally been fully exposed and unpainted as the ceiling for the original parlor chamber.

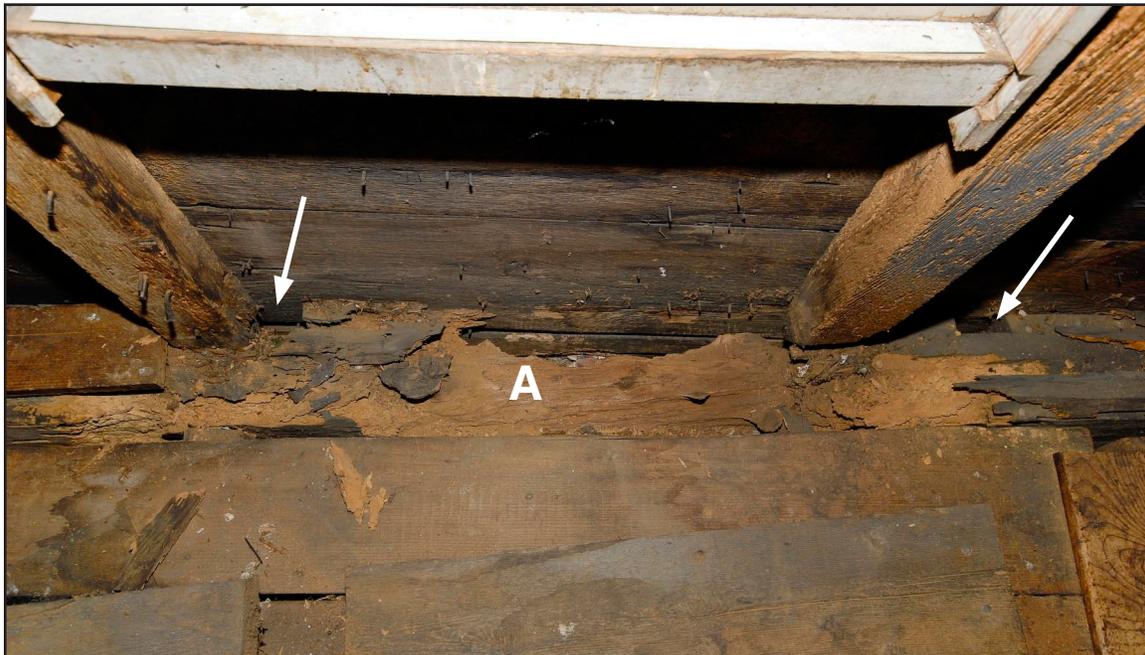
Photo 46: The center of the east end attic tie beam (A) has extensive past rot from years of leaks from the attic window directly above it. Like the parlor chimney tie beam, this beam is probably 9" deep and may still have sufficient sound wood to carry the loads on it. However, it was not probed to determine the full extent of the damage, as the roof shoring made it impossible to lift the adjacent floor board for inspection. The unused open mortises on the far side of the beam are present in this section (Arrows).

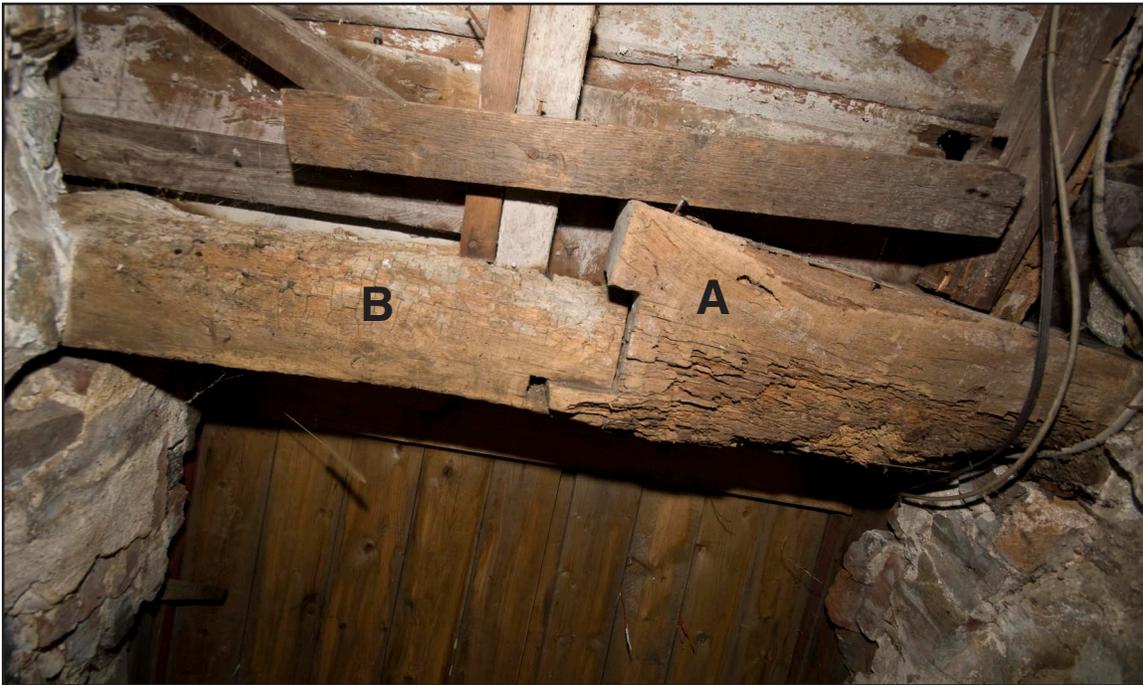
Photo 50: West sill at the cellar bulkhead showing a splice between the original sill on the right (A) and a replacement piece on the left (B). The replacement was probably added in the c. 1840s alterations when the front wall was moved forward 18”. That change would have required that the west sill be extended to meet the new front sill.
