TOWN OF WILMINGTON
DEPARTMENT OF PUBLIC WORKS

SUBJECT: Butters Row Bridge Review
MassDOT Bridge No. W-38-003

DATE: May 4, 2017

STRUCTURES INSPECTION FIELD REPORT

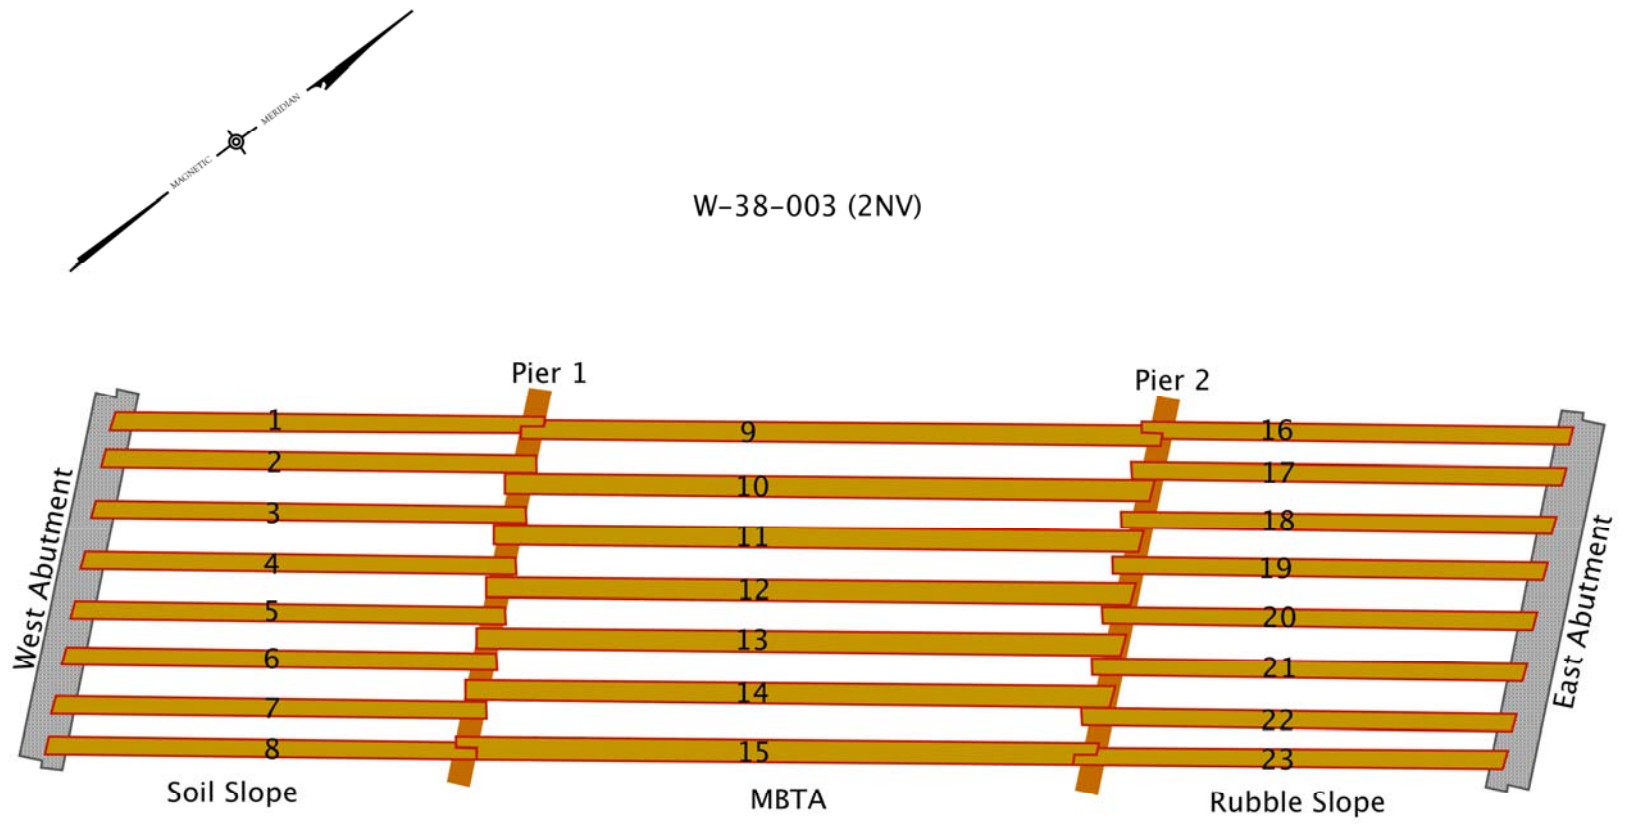
Sketch 1: Framing Plan.

The three span structure carries Butter Row over the MBTA/BMRR. According to the bridge plans, the abutments are labeled West and East. The spans and trestles are numbered from west to east. The timber beams are numbered 1-23 simultaneously from north to south in each span. **See Sketch 1.**

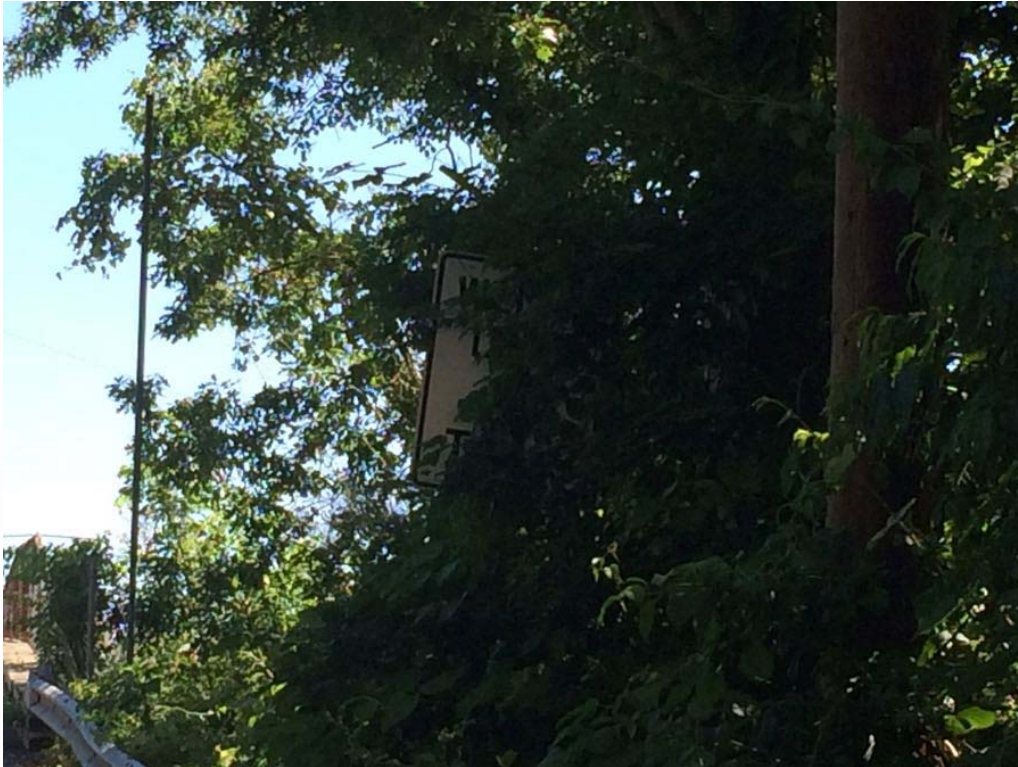
The west elevation "At Bridge" Weight Posting Sign is hidden by vegetation. **See photo 1.**

Photo 1: West elevation, hidden "At Bridge" Weight Posting Sign.

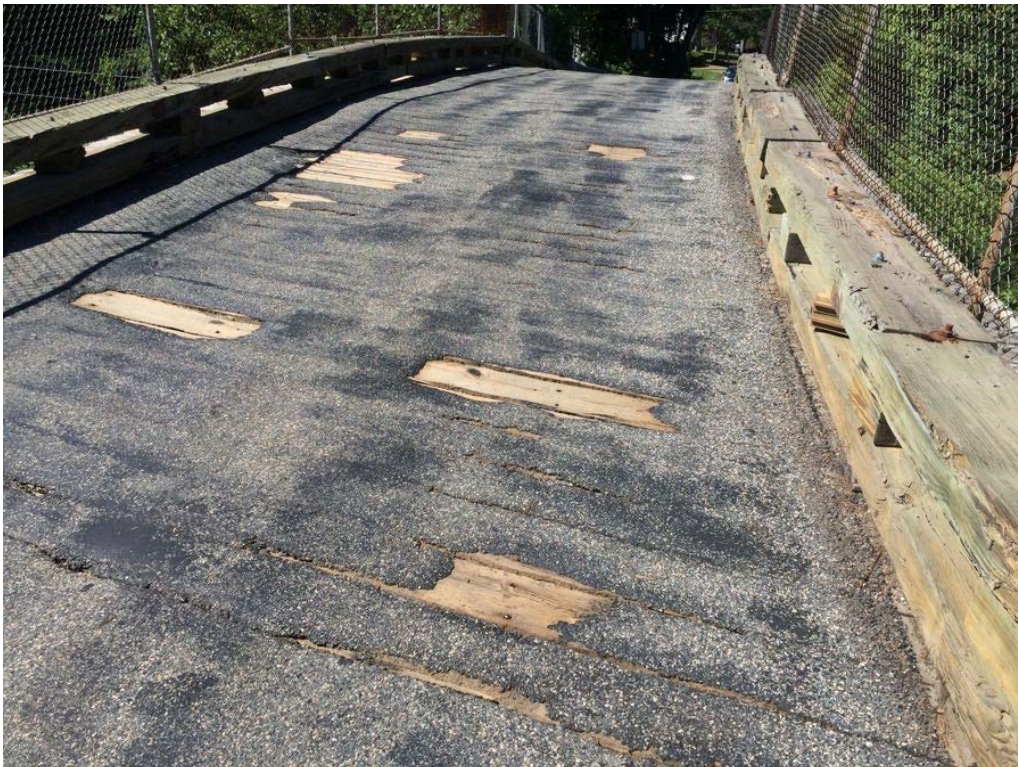
There are large areas of missing bituminous overlay throughout. **See photo 2.**

Photo 2: Typical wearing surface, exposed deck planks.

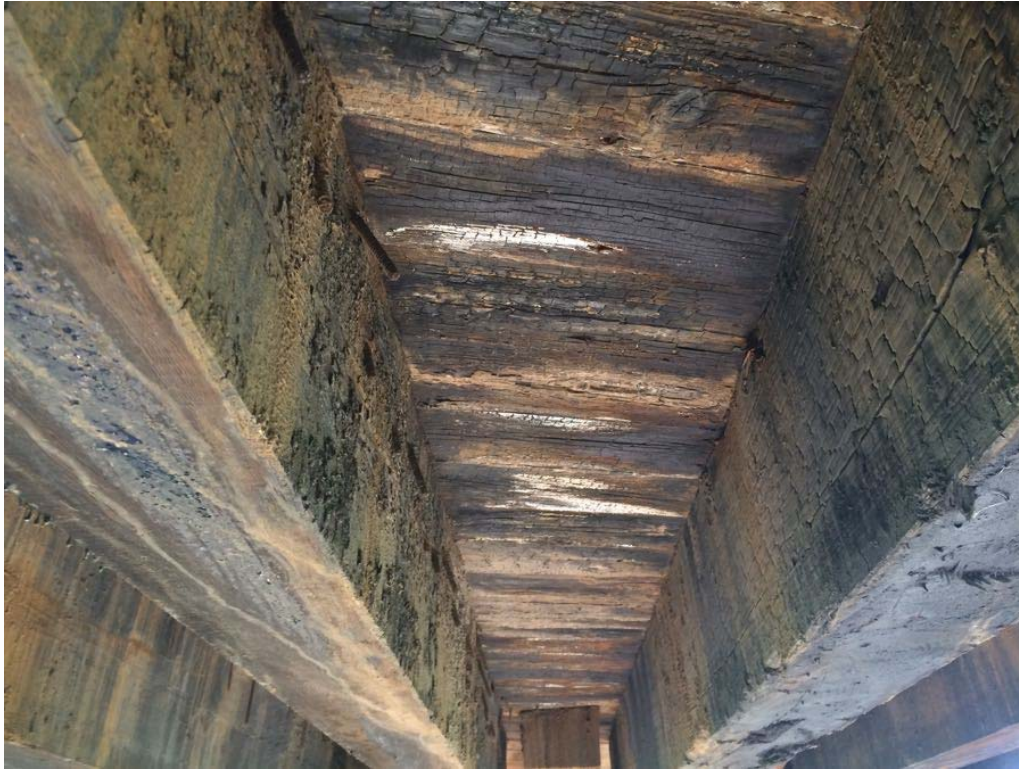
In all three spans, all bays have areas of checking, splitting, and rotting, with moderate efflorescence. **See photo 3.**

Photo 3: Typical rotting, checking, and efflorescence throughout the deck.

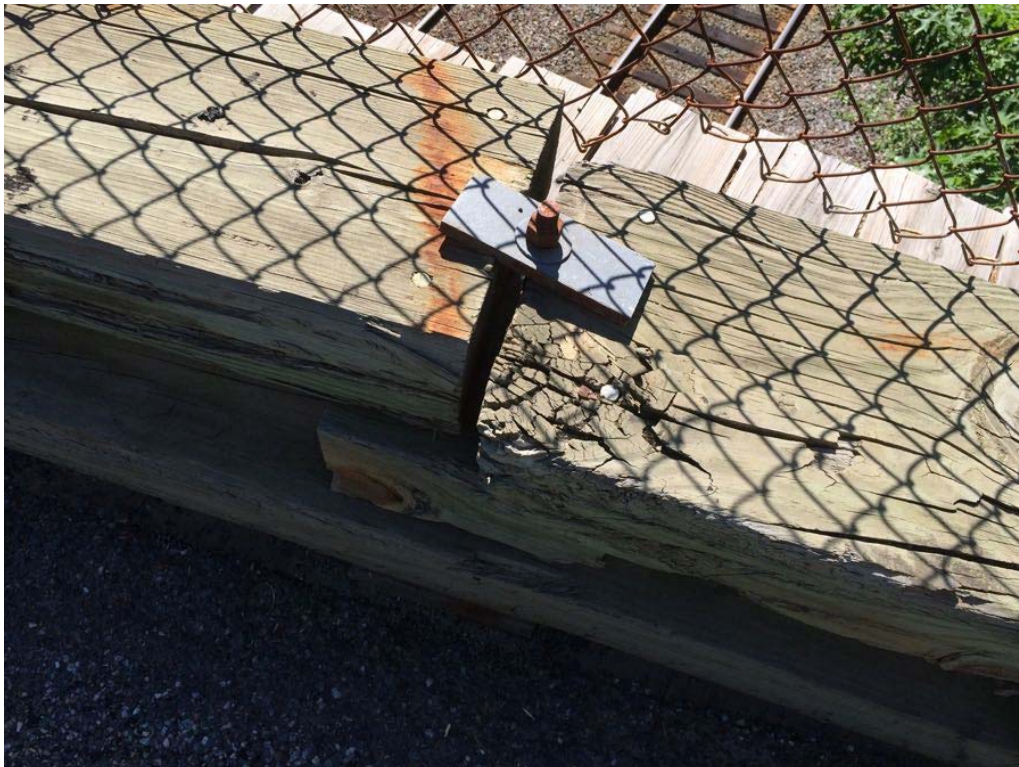
Both curbs have numerous areas of collision damage with loose planks and connections. **See photos 4 & 5.**

Photo 4: Typical timber curb deterioration and loose connection.

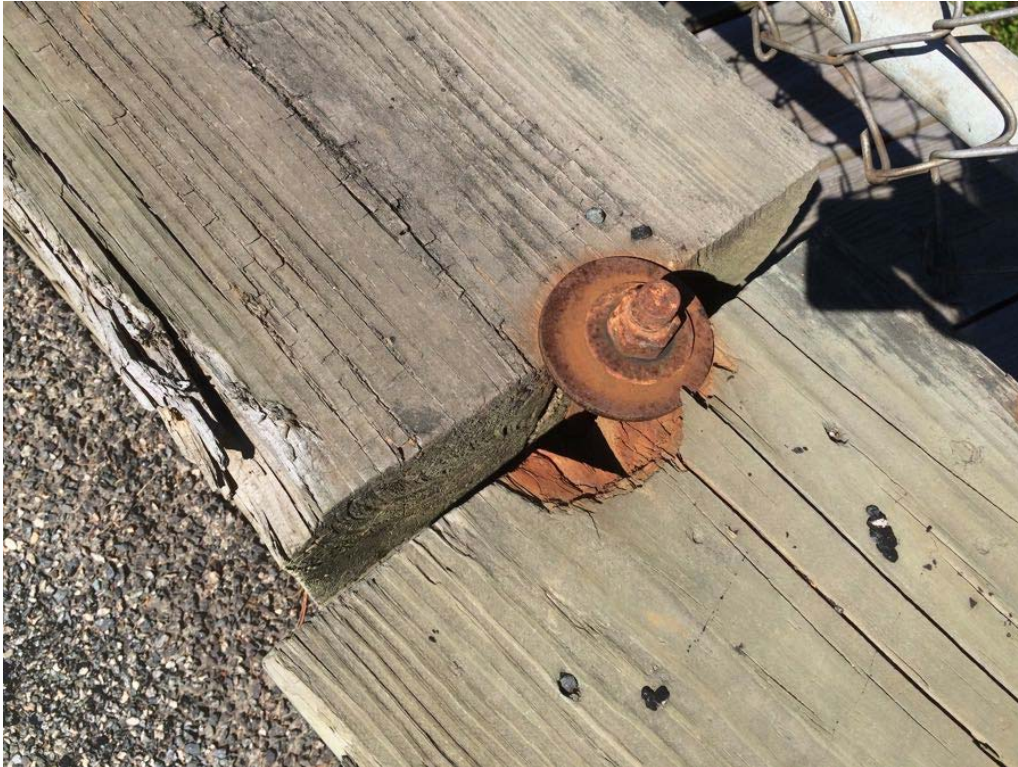
Photo 5: Typical broken connection throughout both curbs.

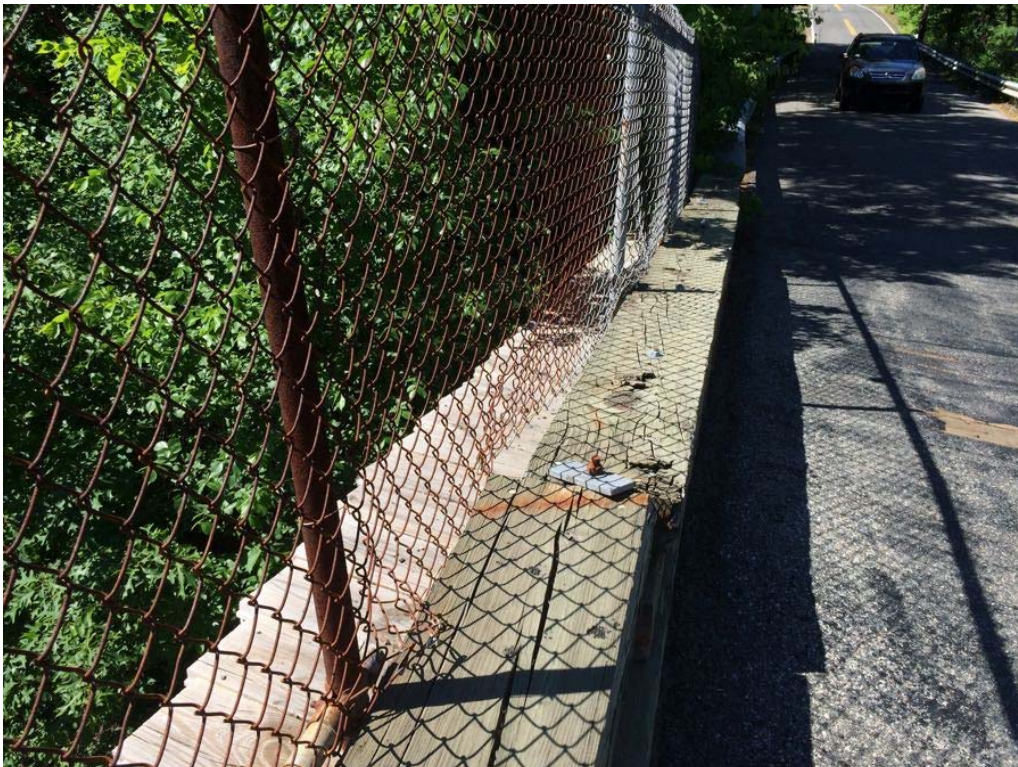
There are several planks leaning into the roadway along the full length of both curbs. **See photo 6.**

Photo 6: Curb area leaning into roadway; typical throughout both curbs.

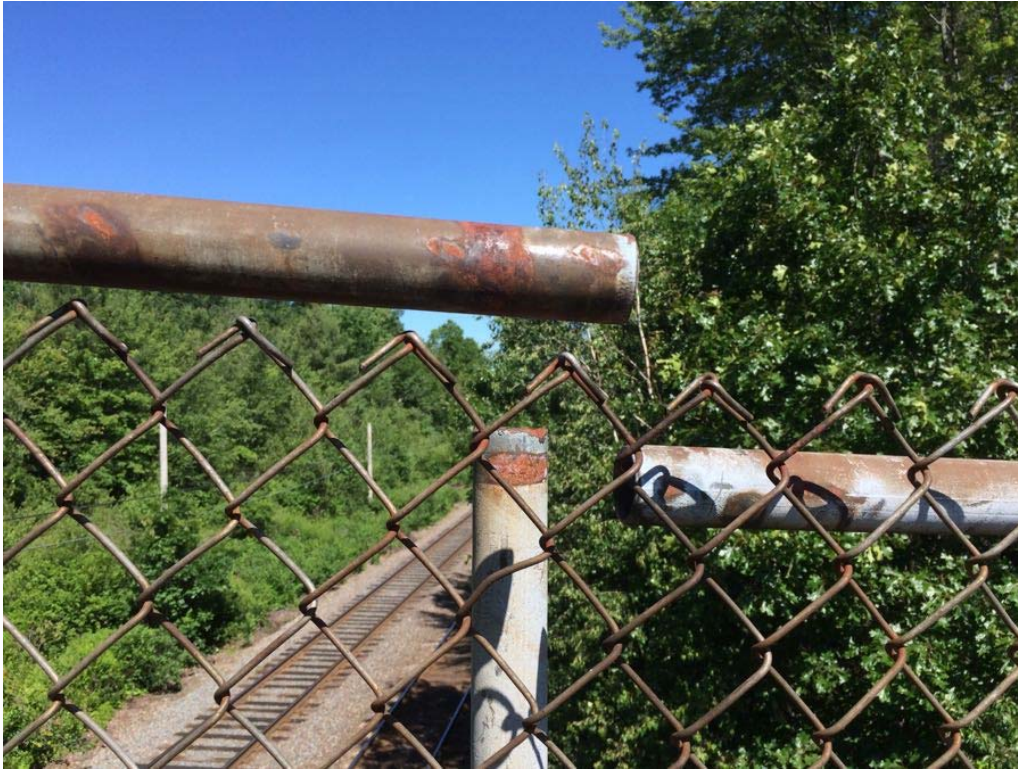
Both fences have areas of broken and loose connections. There are random areas of rust throughout. **See photo 7.**

Photo 7: Typical broken fence connection; view of south fence near the west end.

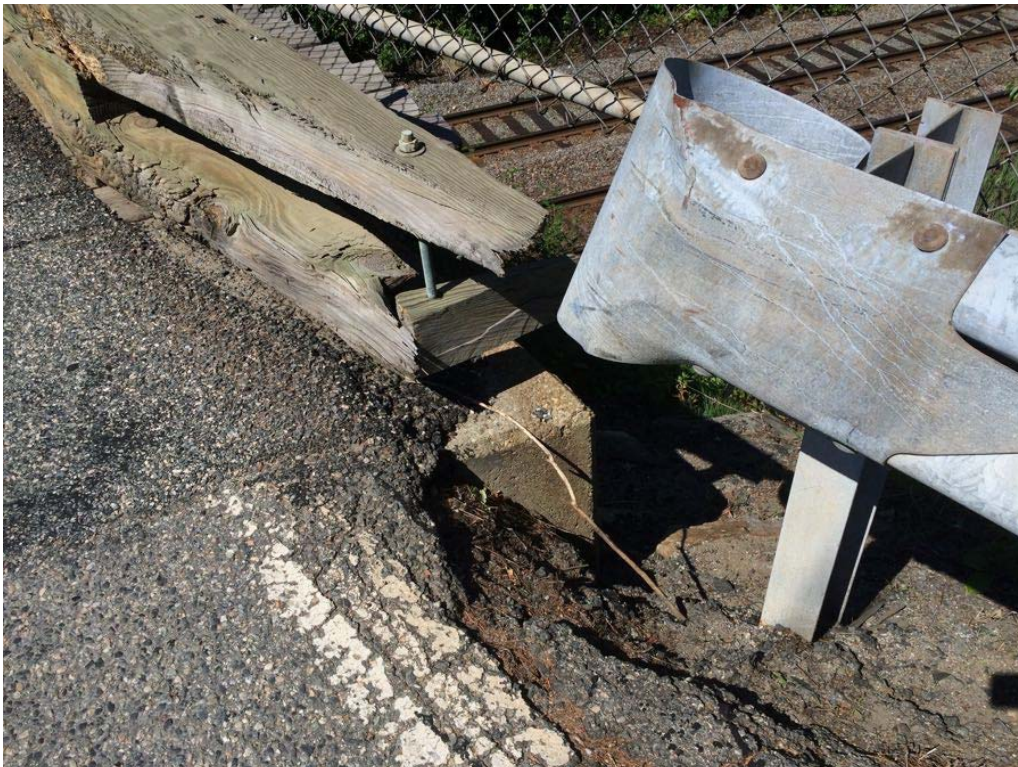
Photo 8: East approach, washout/settlement area at the north corner of the east abutment.

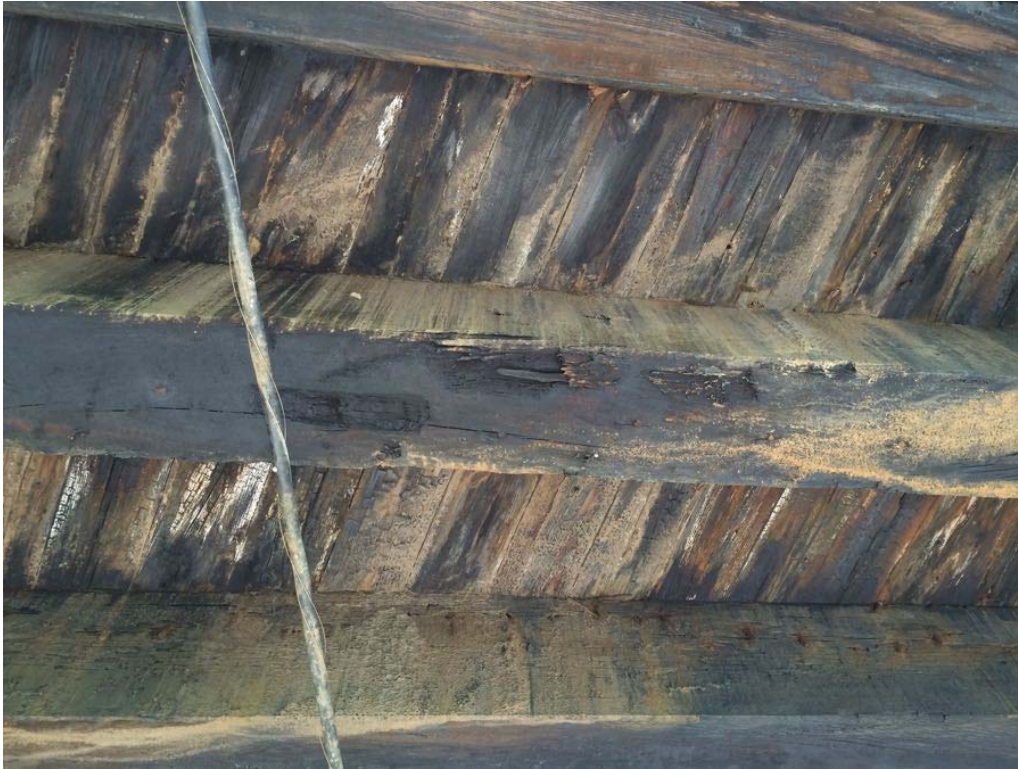
Photo 9: Typical areas of checking and splitting throughout all beams.

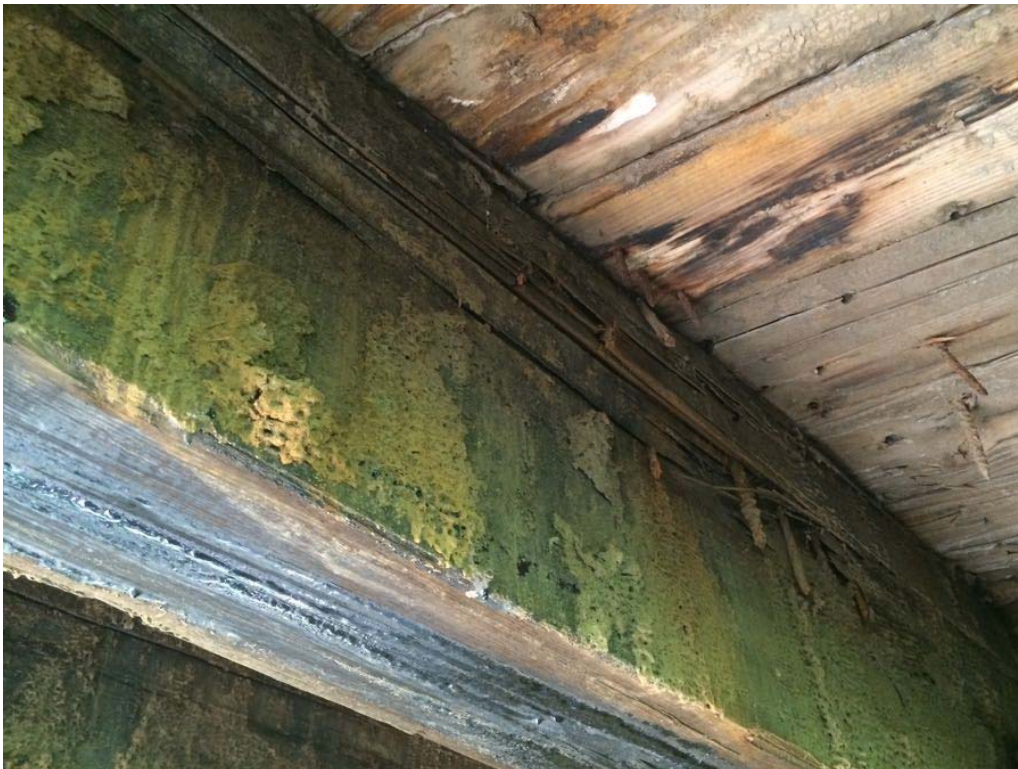
Photo 10: Span 1, typical areas of steel tie rods/nails popping out of both faces of all beams; typical splitting.

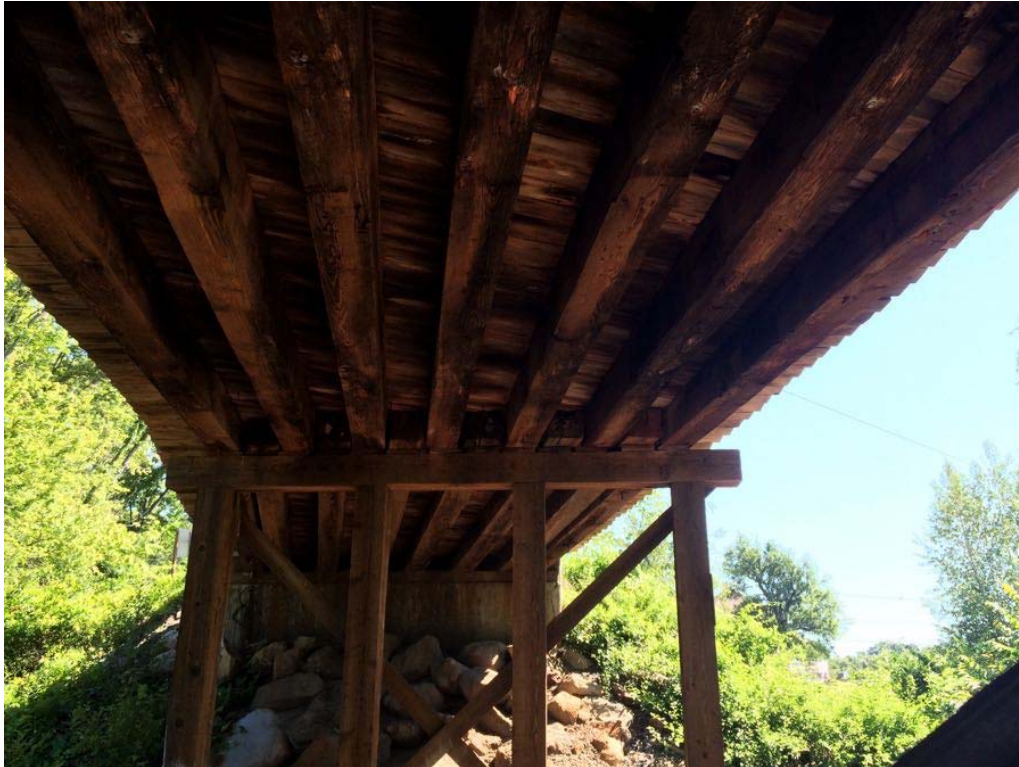
Photo 11: Span 2, typical underside.

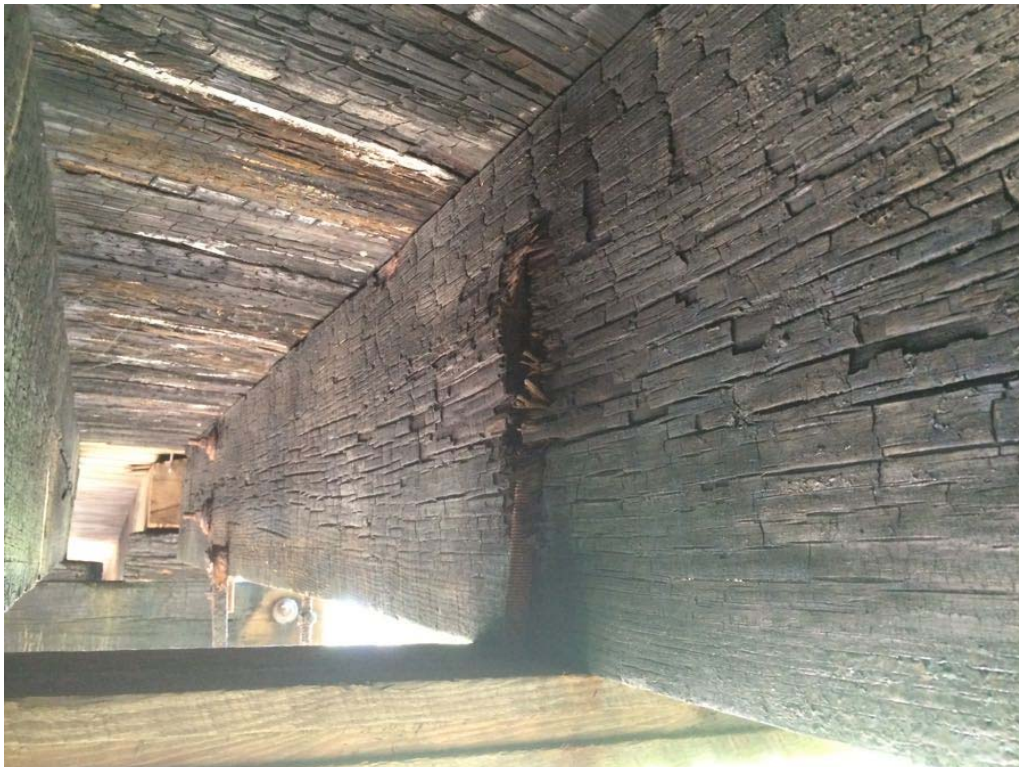
Photo 12: Span 3, typical view of random steel tie rod popping out of beam face.

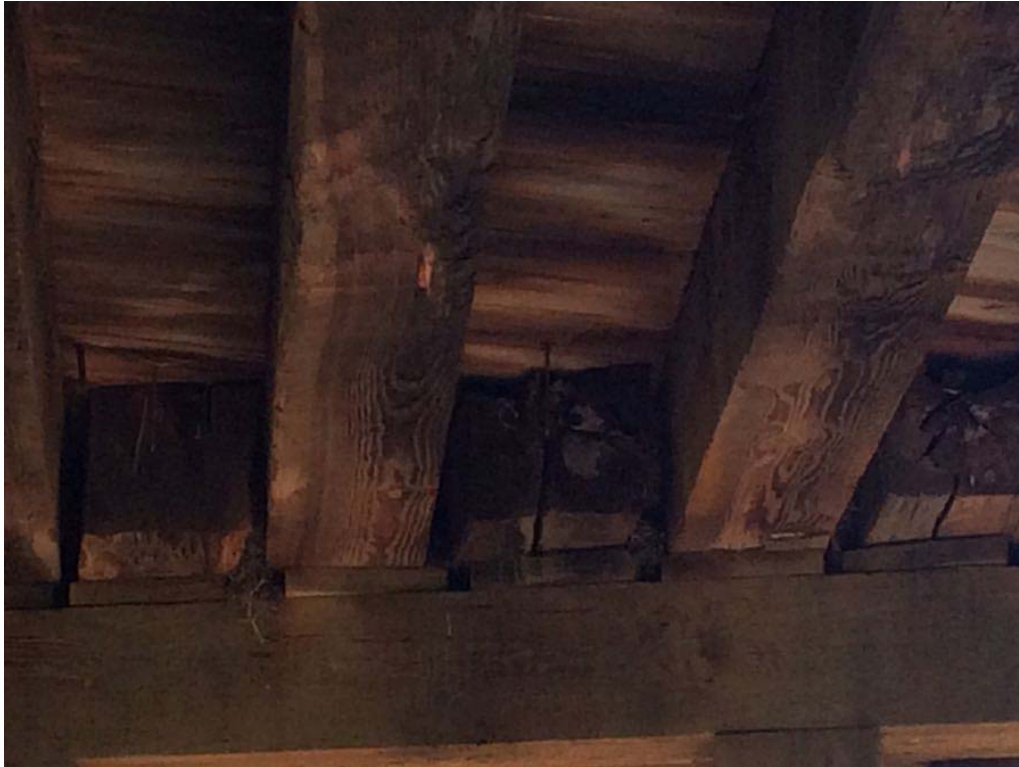
Photo 13: Span 3, west face of Beams 20 & 21, evidence of crippling and moderate splitting.

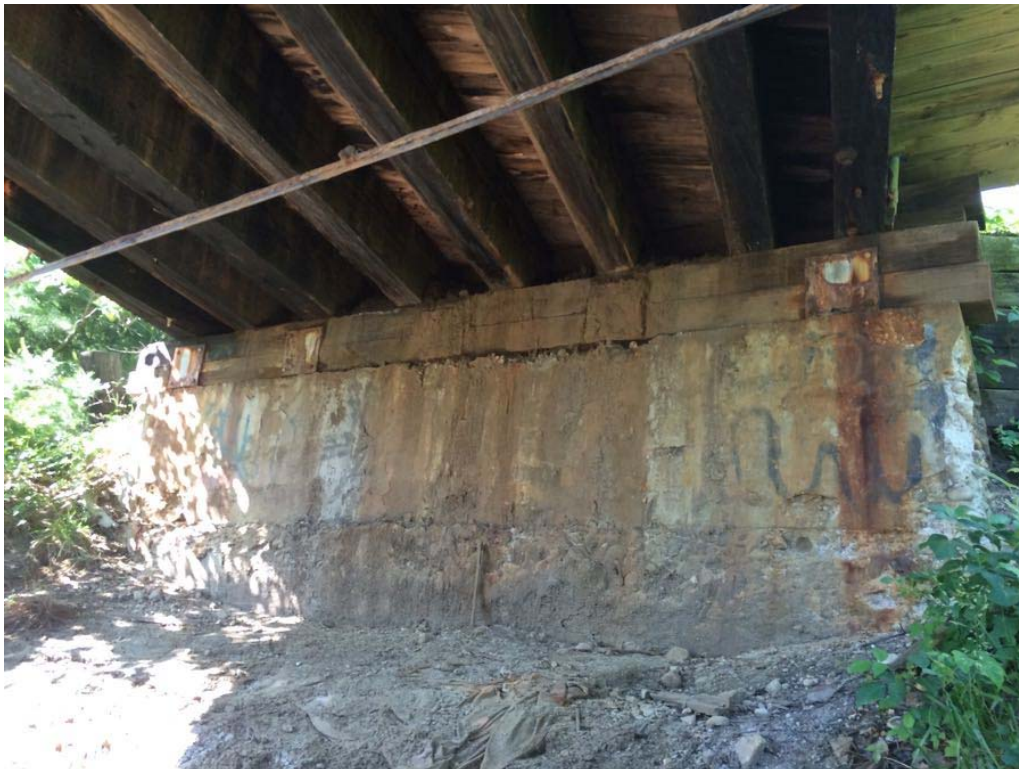
Photo 14: Typical scaling throughout both breastwalls; view of west breastwall.

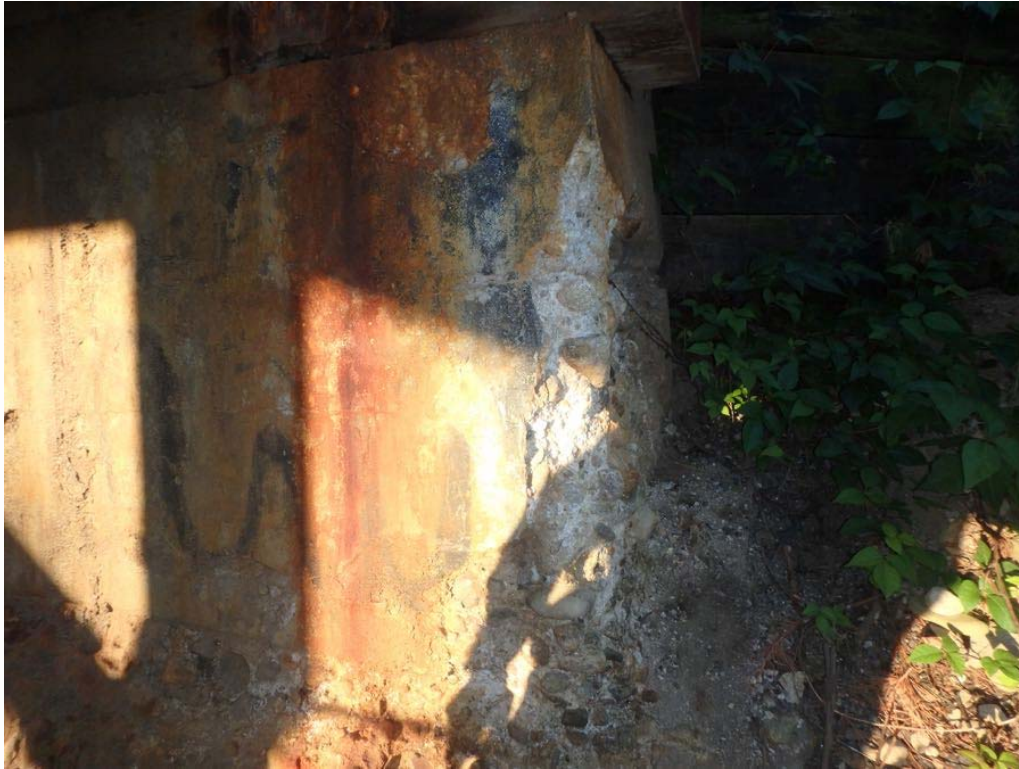
The west breastwall has areas of moderate spalling and scaling throughout, up to 4" deep. **See photo 15.**

Photo 15: West breastwall, north end spalling.

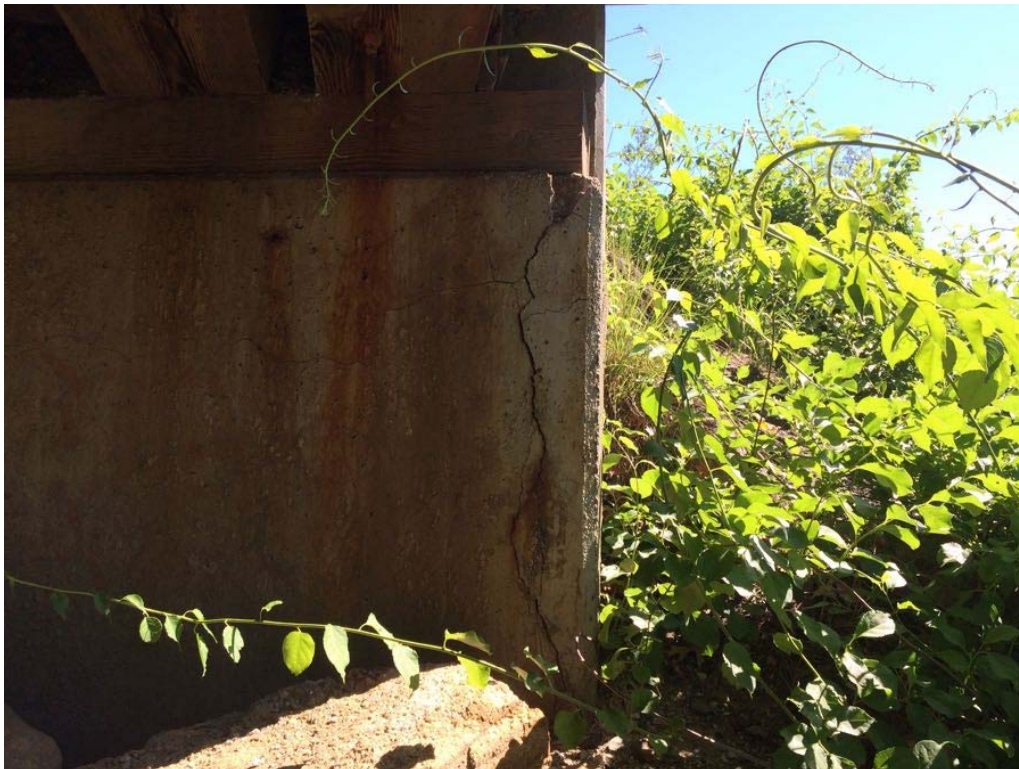
The east breastwall has a full height vertical crack at both ends, up to 1/4" wide. **See photo 16.**

Photo 16: East breastwall, south end vertical crack.

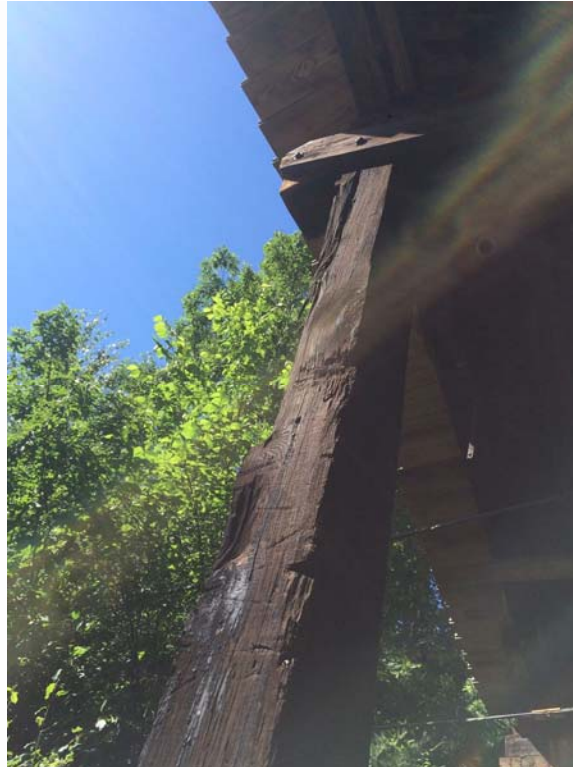
Photo 17: Pier 1, Column 1, typical rotting along the full height of the edges.

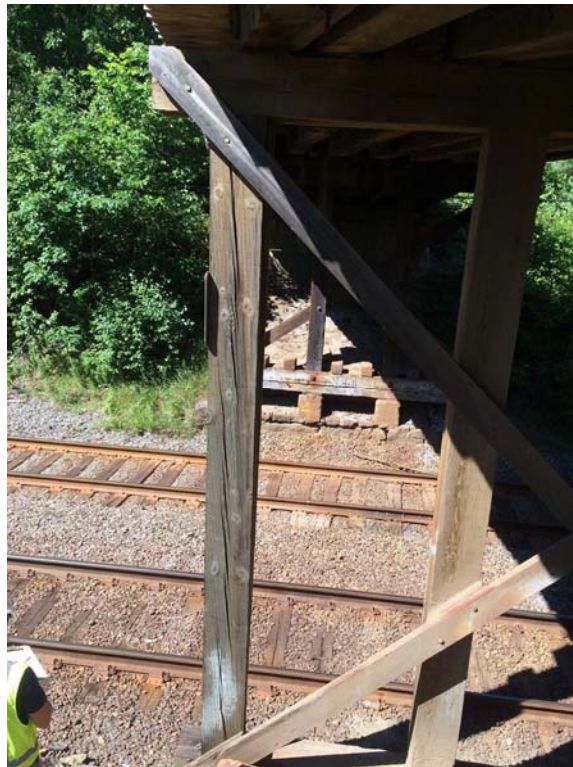
Photo 18: Pier 2, column 1, typical vertical splitting.

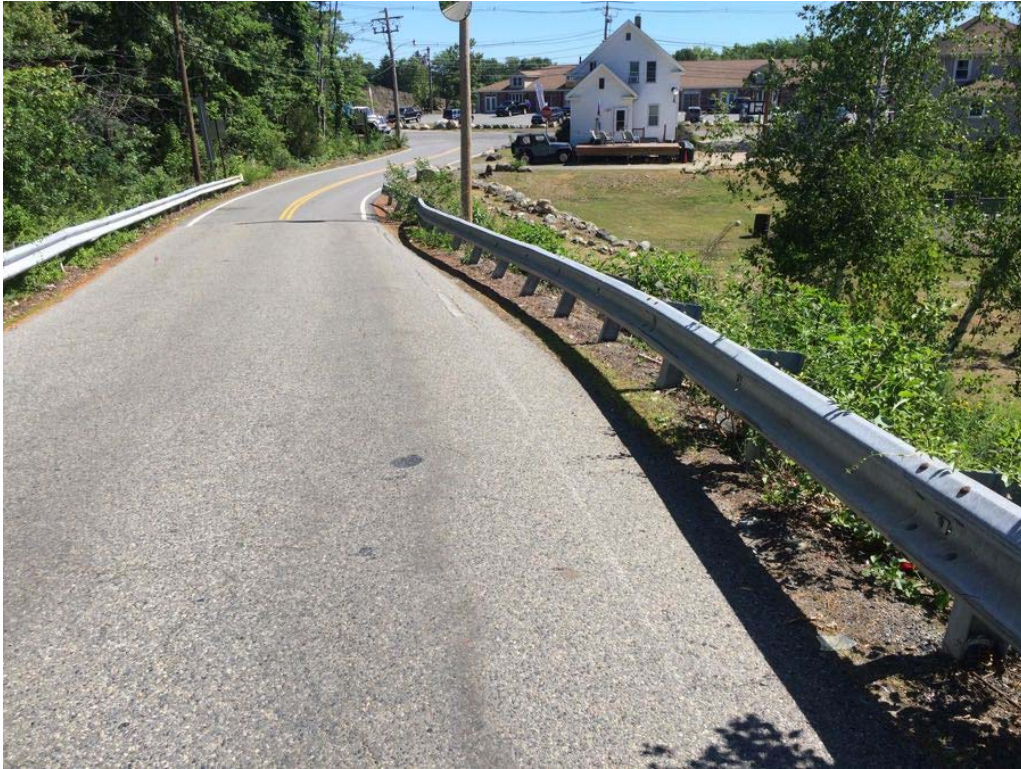
There is moderate damage at both east corners and the southwest corner. **See photos 19 & 20.**

Photo 19: Southeast approach guardrail damage.

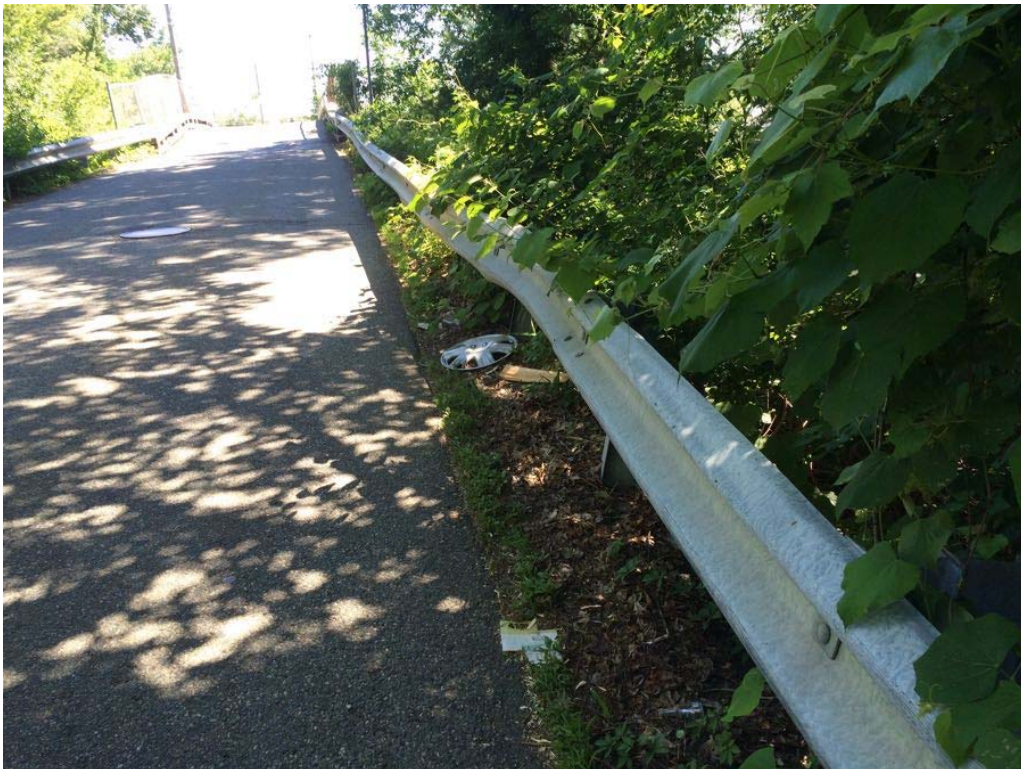
Photo 20: Southwest approach guardrail damage.

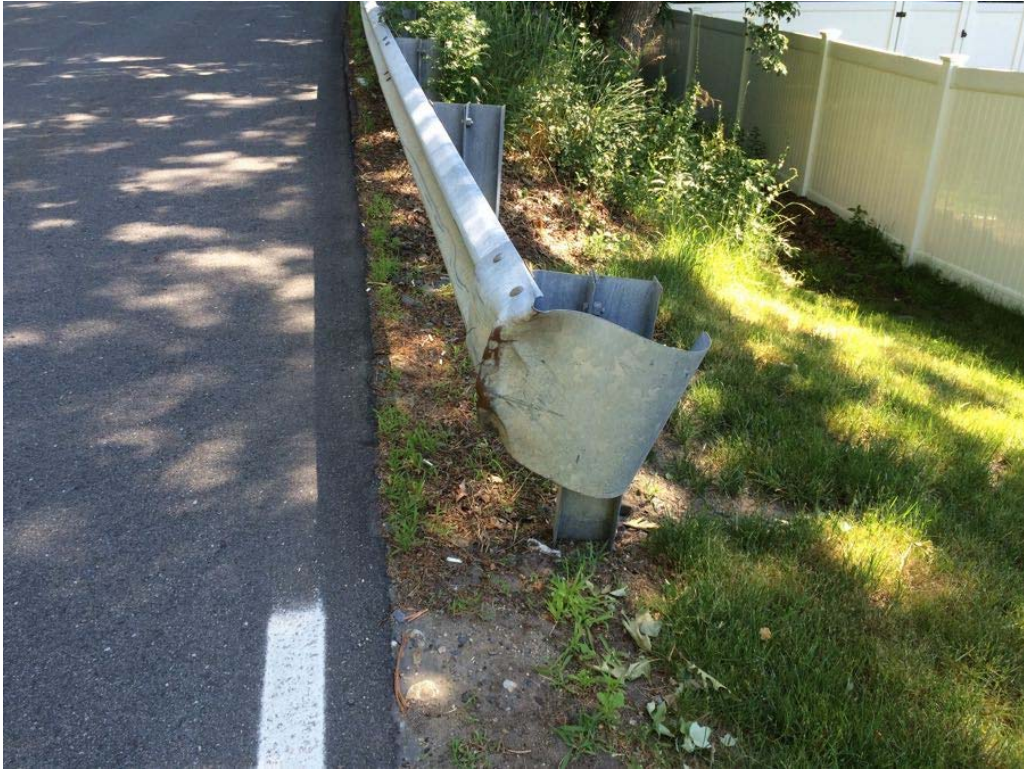
All four corners have minor damage and scrapes. **See photo 21.**

Photo 21: Southwest approach rail end damage.
