HISTORIC ARCHITECTURE ASSESSMENT REPORT

THE WILLIAM BUTTERS II HOUSE

WILMINGTON HISTORICAL COMMISSION

DECEMBER 4, 2007

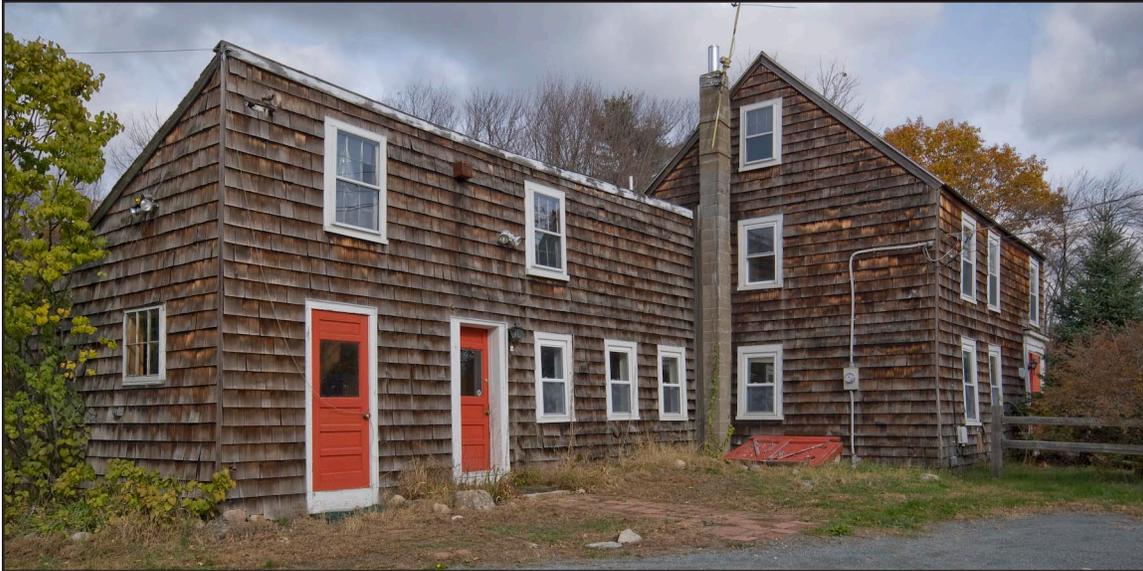
Photo 1: Front (south) and west facades of main house with ell in foreground.

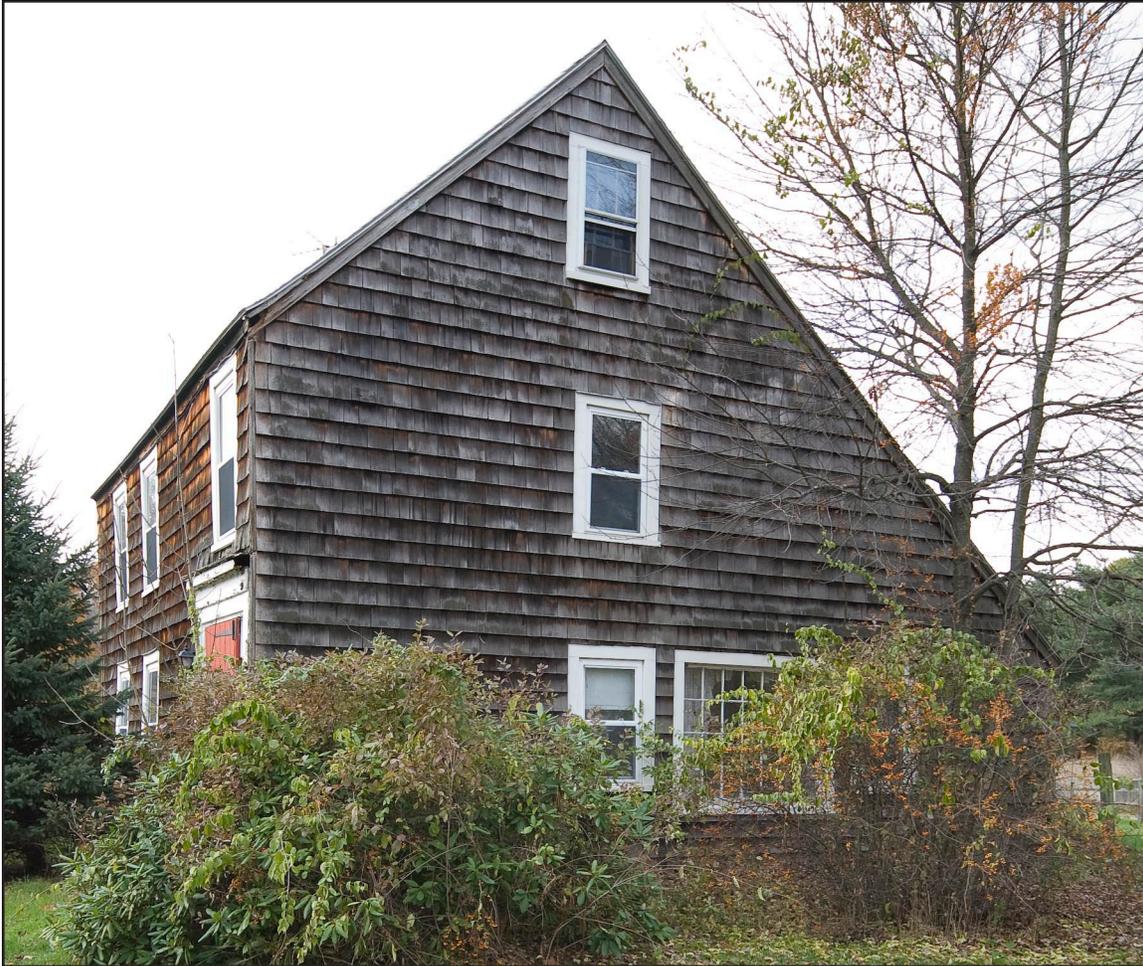
Photo 3: East facade of main house. This side exhibits the classic lines of an 18th century New England salt box (i.e., leanto) house.

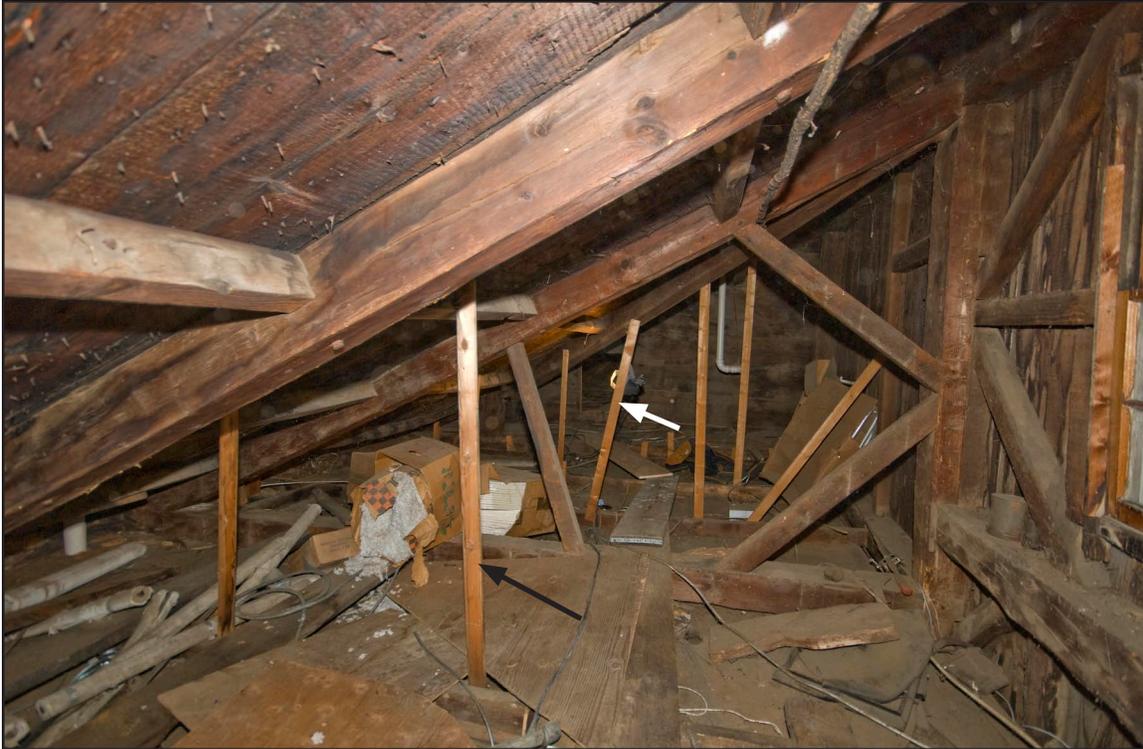
Photo 12: Ell attic above the ell kitchen showing framing on the front wall that is characteristic of barns rather than houses. Vertical struts (arrows) were added in the 1970s to prevent the added wallboard ceiling from sagging. Note cast off pipe insulation in the lower left corner that may contain hazardous materials and should be tested by a hazardous materials professional.

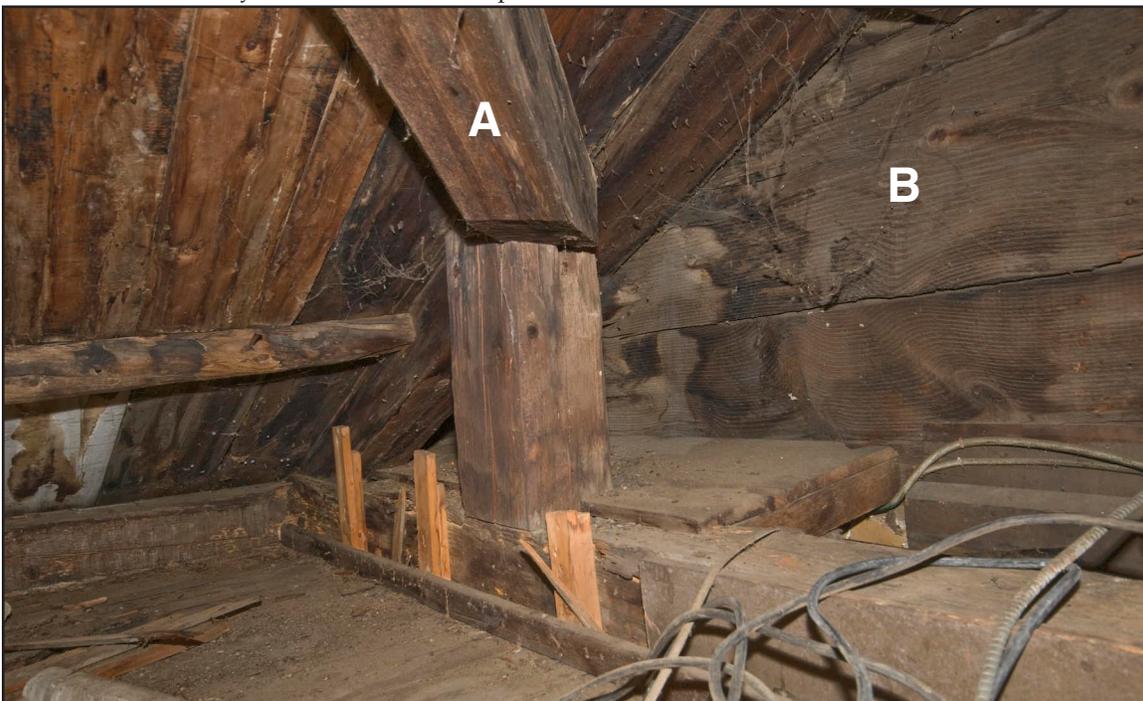
Photo 13: East end of ell showing the make-do manner in which the end of the diagonal rafter marked "A" is supported on a short post cut from a reused timber. Most likely the diagonal rafter is also reused. The sheathing boards marked "B" are on the west wall of the main house. They have a strongly weathered surface and do not appear to have ever been covered with clapboards or shingles. They are nailed to the original wall studs behind them with cut nails indicating they were installed in this position after c. 1800.

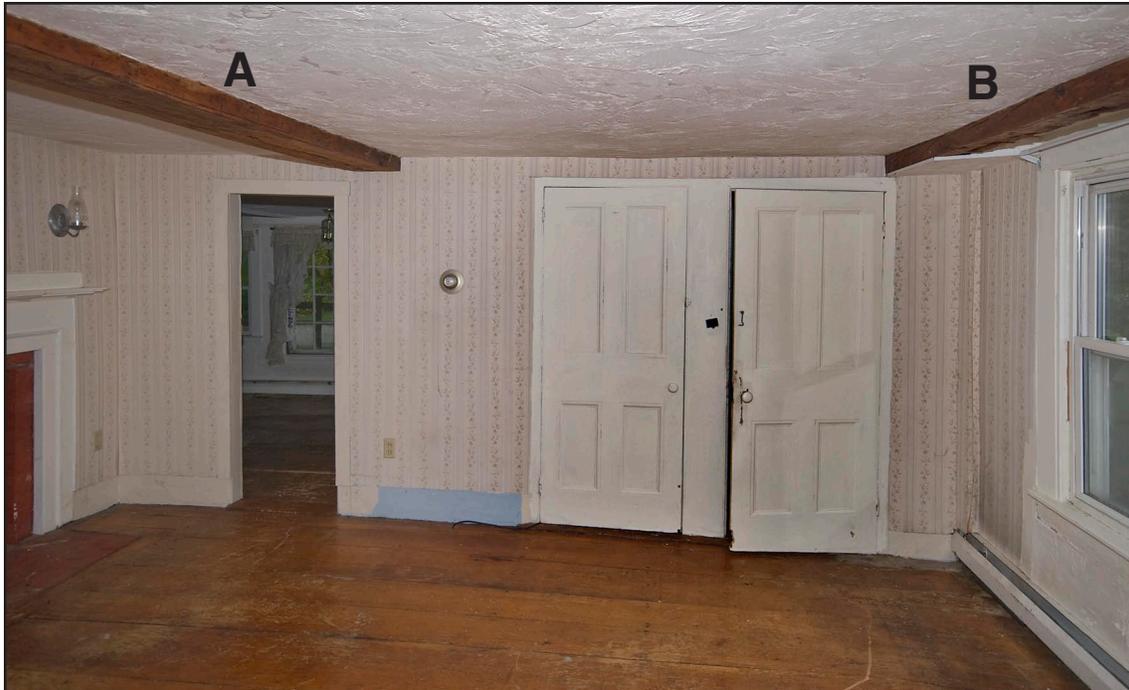
The lower portion of the original 12" wide parlor summer beam is exposed below the current wallboard ceiling where it spans across the middle of the room (Photo 14). Its bottom has been slightly cut back to facilitate the 1840s casings (no longer present), but a portion of its beaded lower edges are still visible at its east end. Like the lower girt, it extends beyond the current east wall into the current rear room where it is hidden under the plaster ceiling.

Photo 14: East wall of parlor (Room 101) with lower portions of the original summer beam (A) and the original lower front girt (B) exposed below the 1970s wallboard ceiling. The lower front girt marks the position of the original first floor front wall.

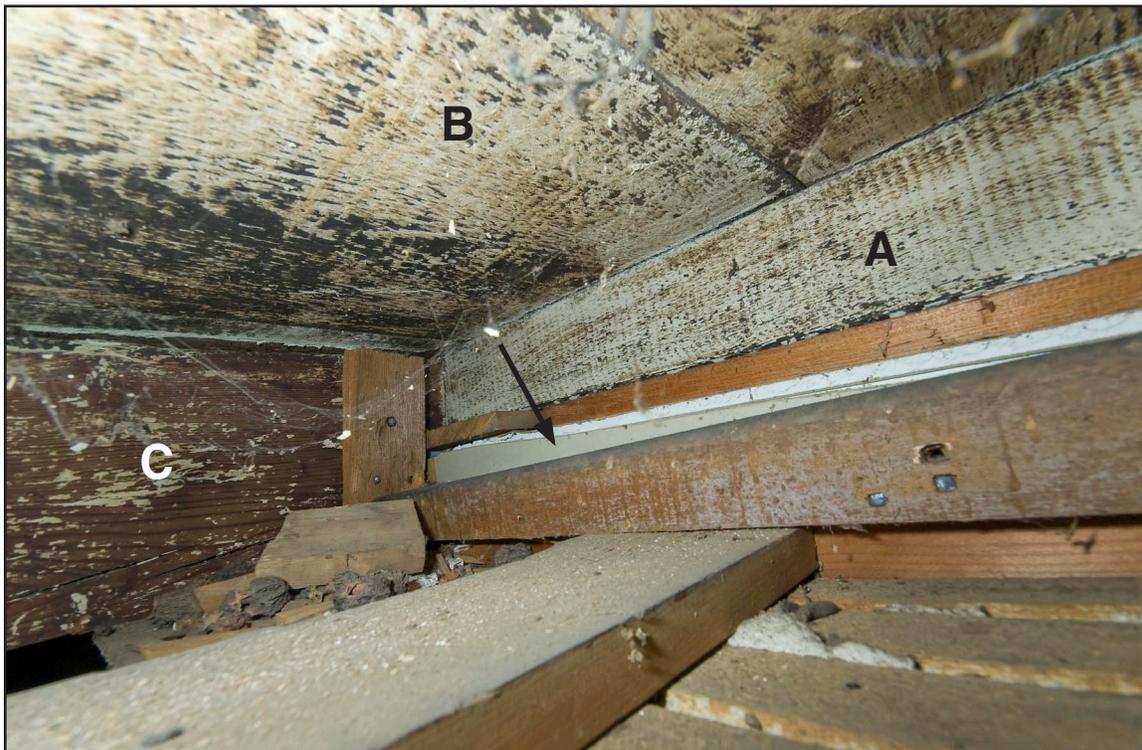
The original joists along with the original second floor subfloor boards remain intact above the current wallboard ceiling (Photo15). The joists are finished with a narrow chamfer on their bottom edges. Both the joists and the underside of the subfloor retain substantial amounts of their original whitewash finishes. Where the 1840s chimney stack penetrates the ceiling the original joists have been cut off and are presumably headed with stringer. Along the rest of the rear wall, the joists extend over the wall to frame into the original rear parlor girt above the ceiling of the current leanto room.

Photo 15: Original parlor framing and ceiling with remnants of its 18th century whitewash paint above the current ceiling in the front entry. "A" marks an original ceiling joist that is directly over the 1840s wall (arrow) between the current parlor and the front entry. "B" marks the underside of the original parlor chamber floor boards that also functioned as the parlor ceiling. "C" marks the lower front girt that was over the original exterior first floor front wall.

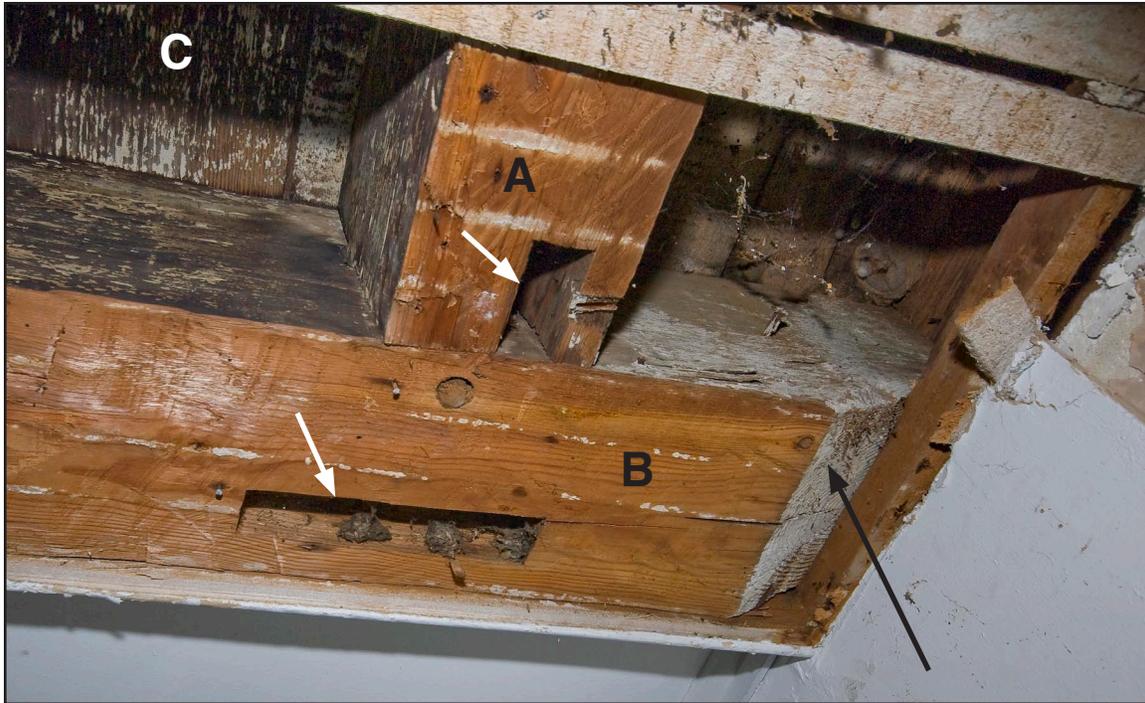
Photo 16: "A" marks the original lower front girt that formed the top of the front wall of the 1720 parlor, "B" marks the original west chimney girt that was above the west wall of the original parlor, "C" marks the ceiling that was within the original parlor, and "D" marks the underside of the second floor that projected beyond the first floor wall as a framed overhang. The black arrow points to the curve that ornamented the end of the girt that projected beyond the first floor wall to carry the overhanging second floor wall. The white arrows indicate the mortises that received the large post (removed in the 1840s) that originally supported these girts. It is not clear how the end of the chimney girt is currently supported. The underside of the girts has been shaved off. This is now in the entry hall and could be revealed by a removable panel.

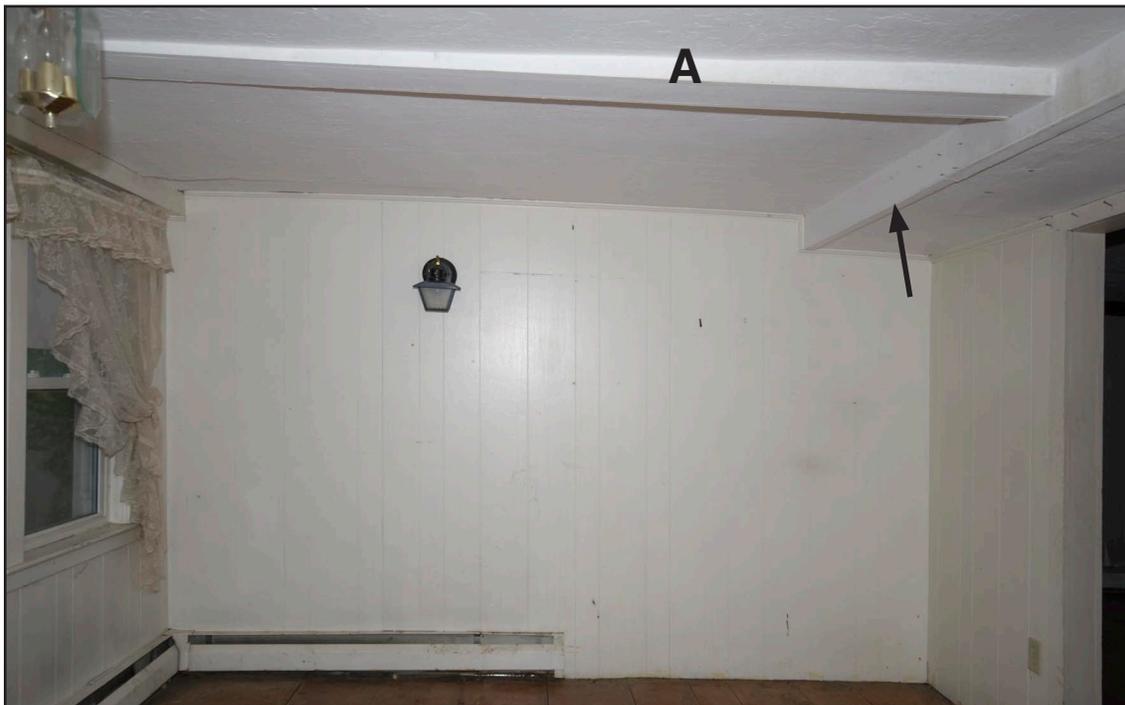
Photo 17: South wall of the northeast room (Room 103). The ceiling at the arrow is lower to cover the west chimney girt. The beam at "A" dates to the 1840s or later. The original chimney occupied this space.

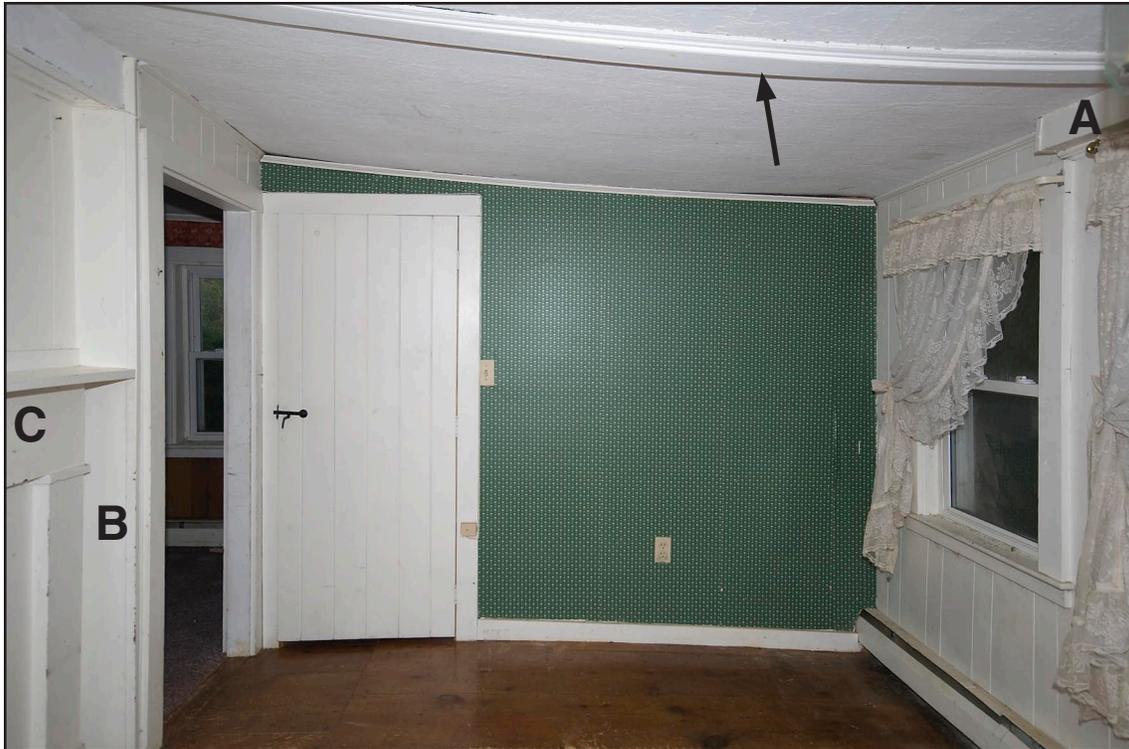
Photo 18: Northeast room (Room 103) looking north. The downward slope of the ceiling over the wallpaper shows how much the east exterior wall (right) has settled. That the wallpaper has not wrinkled in the corners suggests there has not been much movement since the 1970s or 80s. The arrow points to the location of a former c. 1840s partition. "A" marks casing over what may be the original east chimney girt. "B" marks casing over the original west rear chimney post. "C" marks a cosmetic mantel likely installed c. 1910.

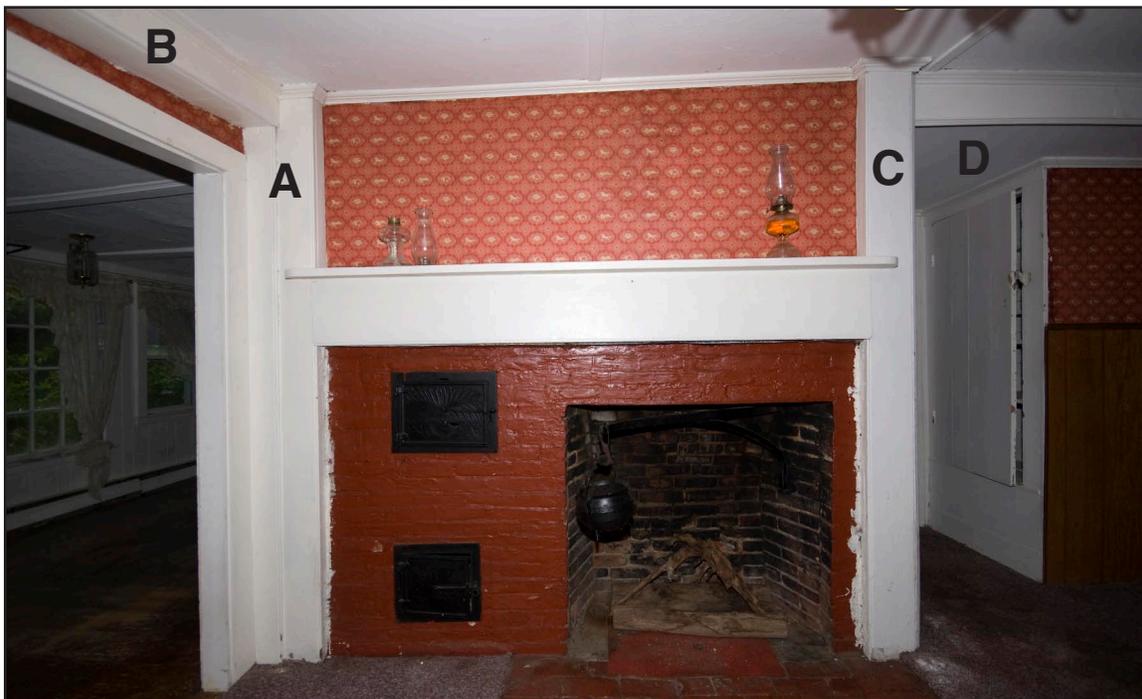
Photo 19: C. 1840s fireplace, bake oven, and ashpit in the leanto kitchen. "A" marks c. 1840s casings over the original west rear chimney post, "B" marks the original leanto chimney girt. The woodwork at "C" also dates to the 1840s. The ceiling at "D" has been lowered to cover the rear parlor girt and floor joists. The fireplace, hearth, oven, and elements marked "A", "B", and "C" should be retained and preserved.

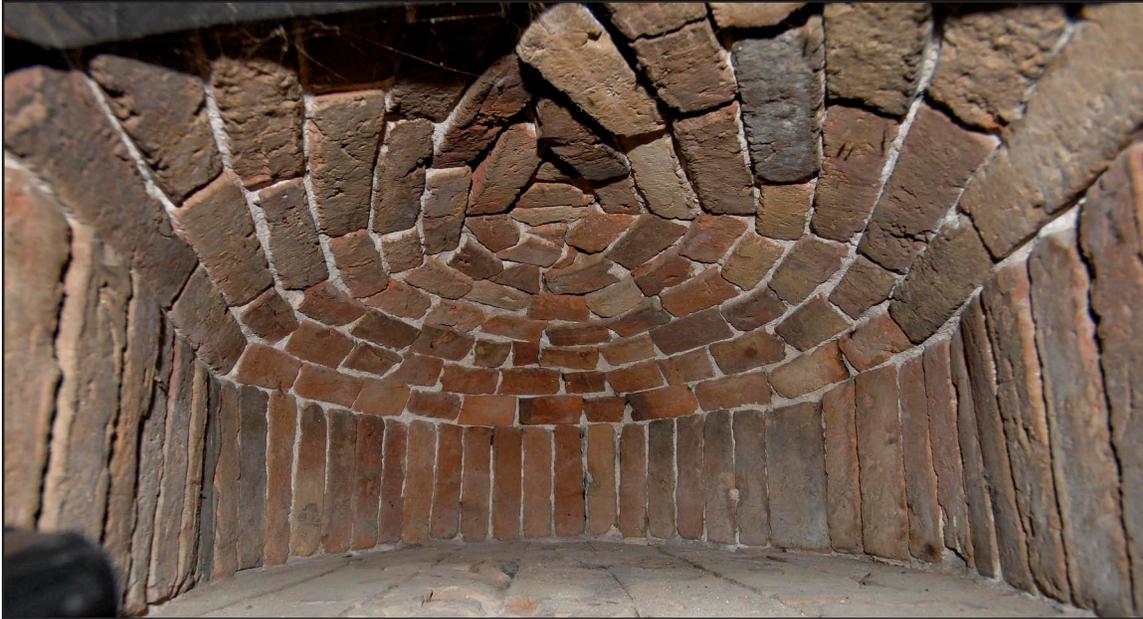
Photo 20: Interior of the c. 1840s bake oven. The left side of the oven is directly behind the mantel in room 103, making it impossible to have had a fireplace at that mantel.

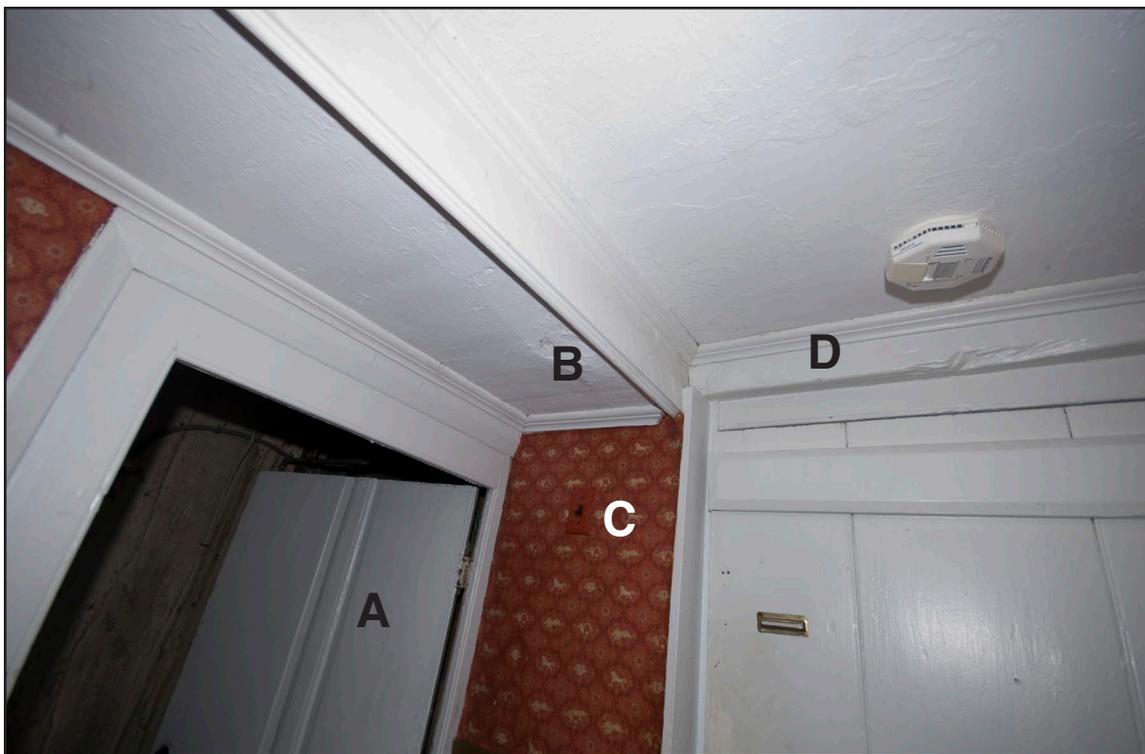
Photo 21: Southwest corner of leanto kitchen. "A" marks c. 1720-50 batten door with feather edged boards reused as the door to the cellar stairwell installed c. 1840s. "B" marks the lowered ceiling that covers the original rear parlor girt. "C" is a board wall that covers the original rear west corner post. "D" marks the original rear leanto west end girt. The area at "B" and "C" would be a good location for a removable panel for viewing the original framing. Alternatively, the lowered plaster ceiling and adjacent board facing together with the boards over the post could fully removed to leave the original framing and floor joists exposed in this area. The girts and post appear to be fully intact with their beaded edges in this area.

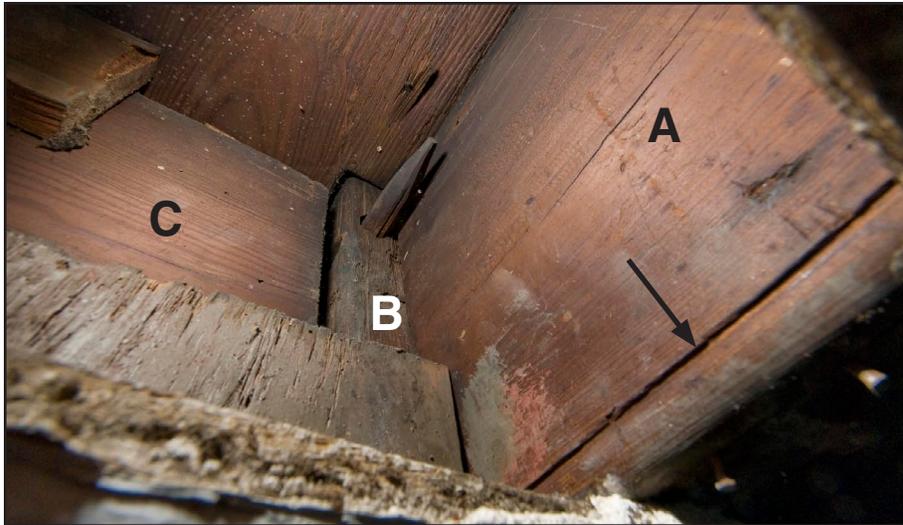
Photo 22: The joint between the rear parlor girt (A), the rear west corner post, and the west parlor girt (C) above the ceiling at "B" in Photo 21. The arrow points to the ornamental bead on the lower edge of the parlor girt.

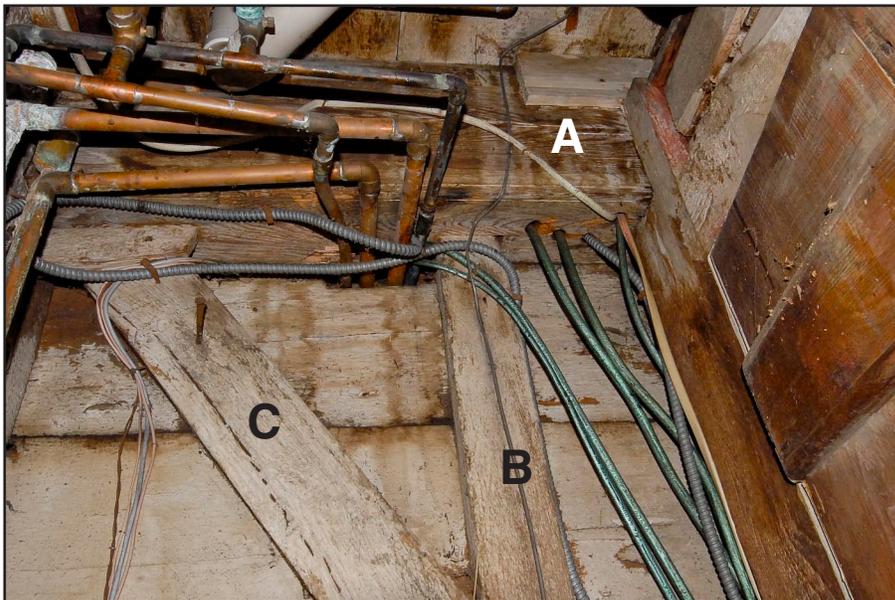
Photo 23: Original west wall parlor framing that remains visible in the cellar stairwell, unfortunately obscured by plumbing for the bathroom above (Room 201B). "A" marks the west parlor wall girt, "B" marks a wall stud, and "C" marks a rising diagonal brace, which were installed at each corner of the original frame.

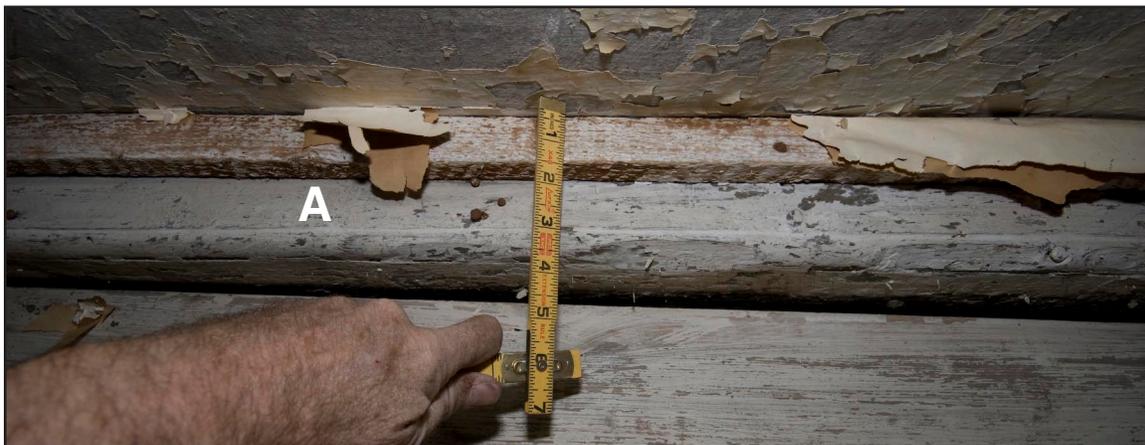
Photo 24: The leanto west wall girt (A) with its original beaded edge as visible within the leanto kitchen closet (Room 104B). The presence of beads on the leanto girt and roof plate matching the beads on the beams in the main house is one of several indications that the leanto was built at the same time as the main house.

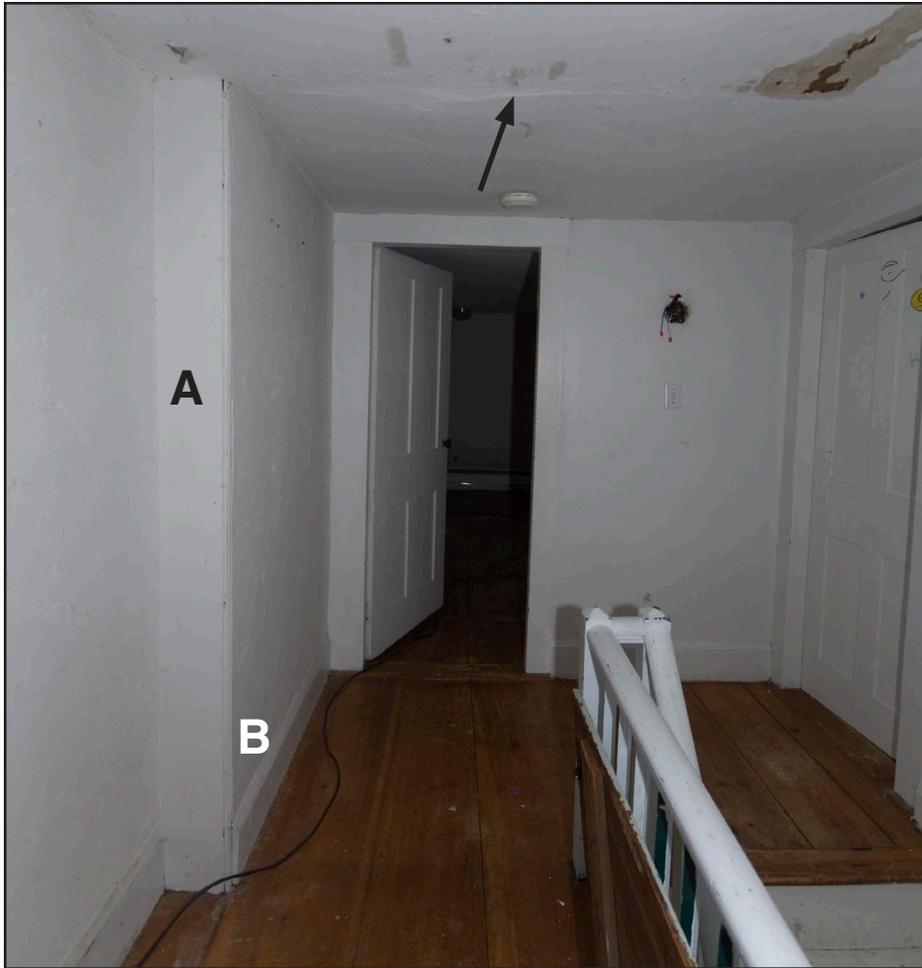
Photo 25: 2nd floor stairhall (Room202) looking towards parlor chamber. The front wall at "A" jogs out to cover the front chimney corner post and other original framing for the front wall of the original parlor chamber. The arrow points to a crack across the ceiling that reflects the position of the attic chimney tie beam that frames into the corner post above "A". The wall between original parlor chamber and the original stair-hall would have been under this tie beam. The dark spot on the ceiling in the upper right corner is a water stain from an active roof leak.

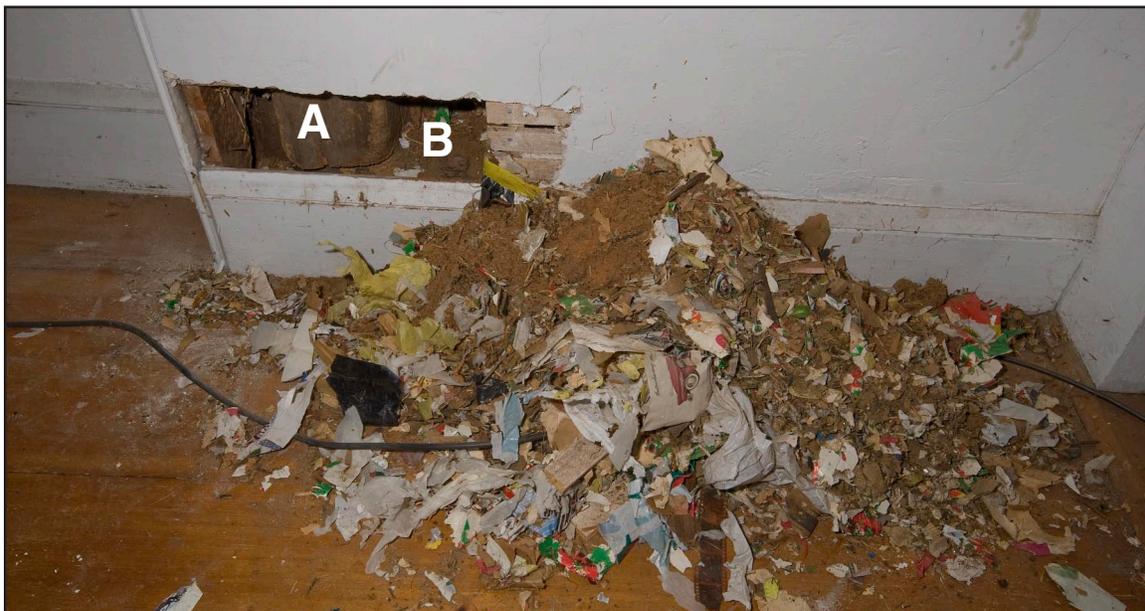
Photo 26: Hole cut in 1840s plaster in area marked "B" in Photo 25 above reveals the bottom of the original second floor front chimney post mortised into the top of the original overhanging upper girt marked "A". The top of the girt is about 5" above the level of the floor. The pile of debris was found in the wall and is from years of rodent nests. Similar debris fills the lower 2' of the rest of the front wall in the parlor chamber.

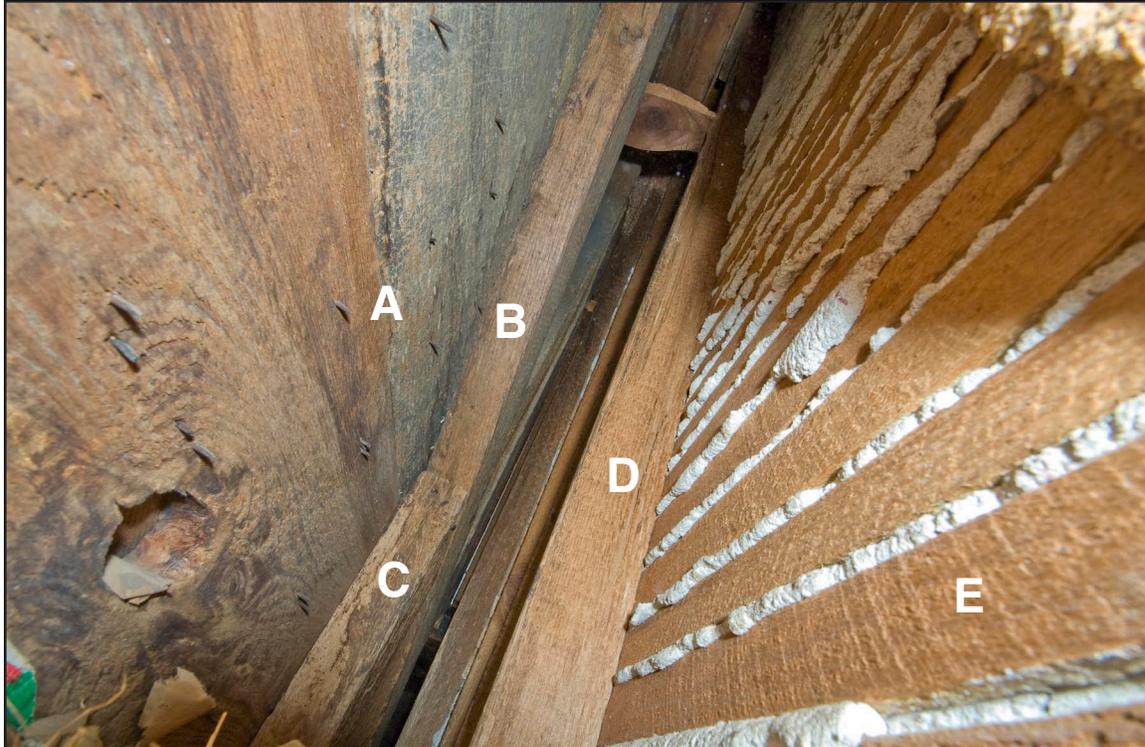
Photo 27: Front wall cavity photographed from the wall opening in Photo 26. "A" marks the exterior sheathing, "B" is an original diagonal corner brace (in this case a falling brace from the corner post to the front girt at the bottom of the wall), "C" is an original wall stud. "D" is a wall stud and "E" circular sawn plaster lath, both for the wall installed in the 1840s to conceal the original framing. Based on this photograph, the original interior room finishes that would have been installed on "B" and "C" were completely removed when the wall was furred out in the 1840s alterations.

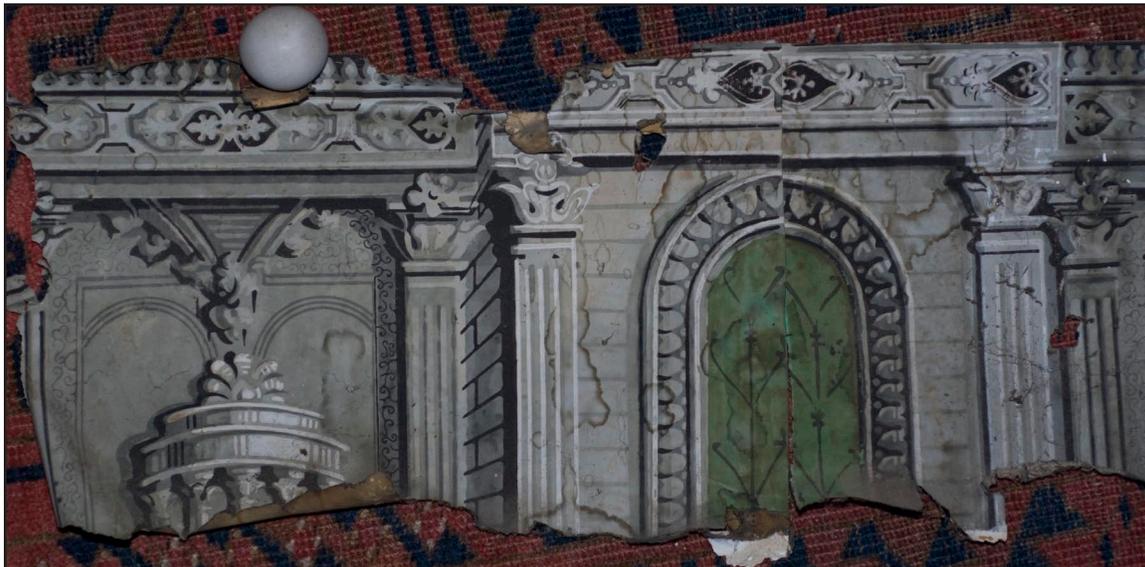
Photo 28: Fragment of wallpaper that was removed from behind the staircase to the attic on the c. 1840s plaster wall. This is an architectural pattern wallpaper that probably dates to the mid-19th century.

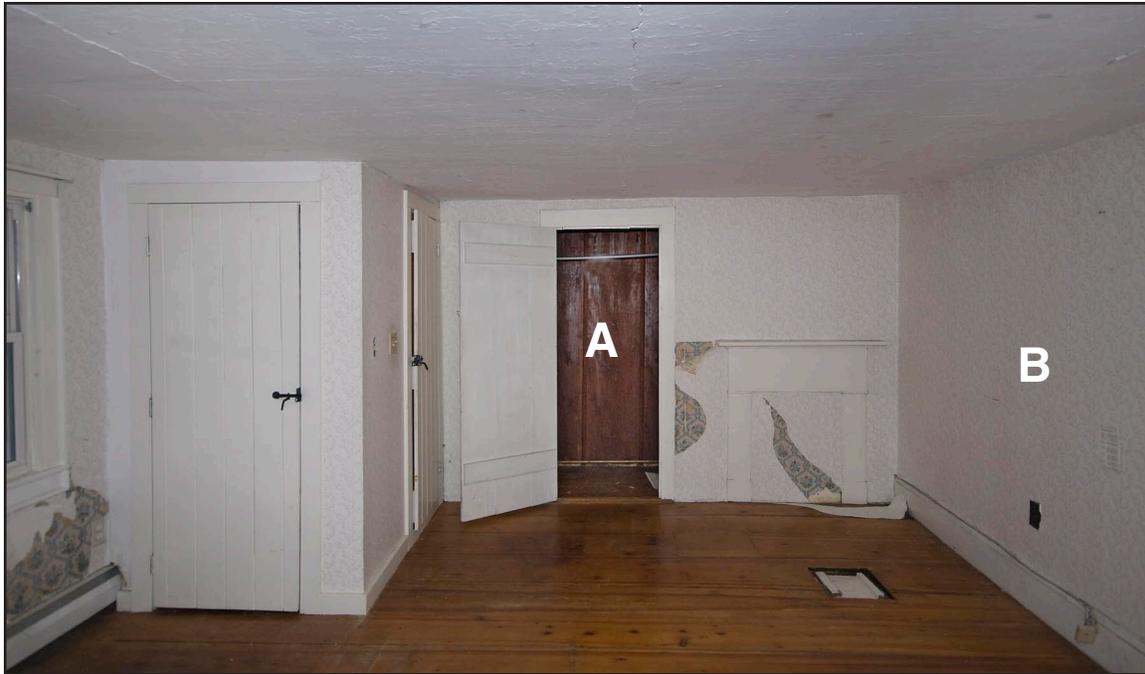
Photo 29: Rear (north) wall of the current parlor chamber. The position of the original parlor chamber rear wall was at the back rear closet marked “A” where there is currently reused 18th century board sheathing. The original east wall was about 44” beyond the current east wall marked “B”. The mantel on the rear wall never had an open fireplace, but might have had a hole for a stove flue into the chimney behind it. The hole in the floor at the right was probably for a cast iron gate to allow warm air to rise from the below prior of the installation of central heating.

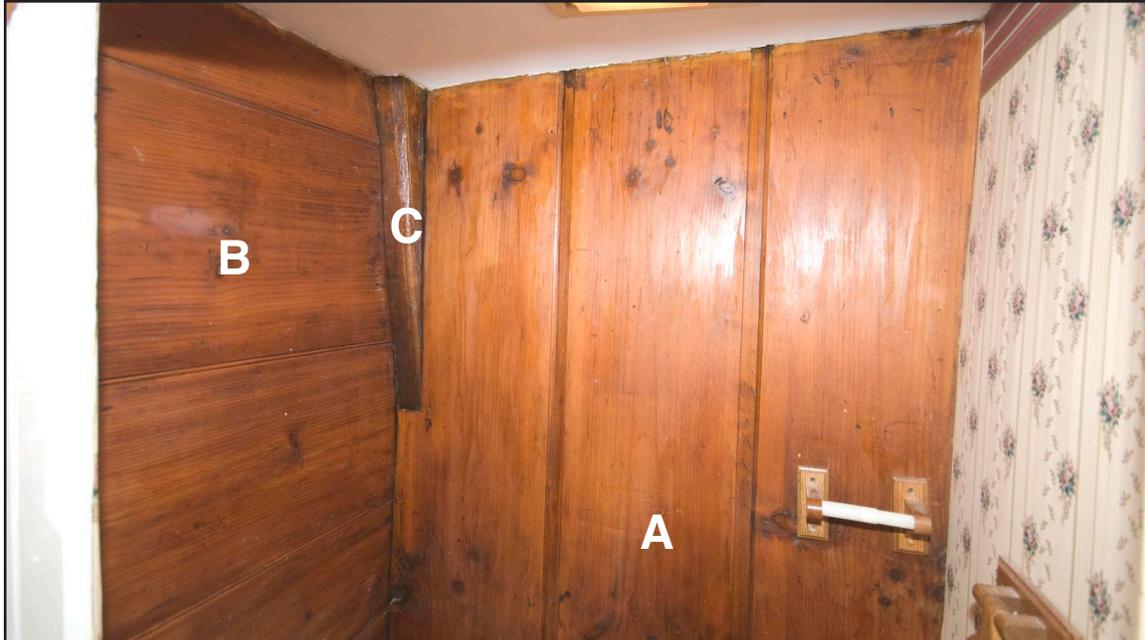
Photo 30: Early board sheathing on the back and west side walls of the bathroom (Room 201B). The sheathing marked “A” is a type known as feather edged sheathing and dates to the 18th century, but was reinstalled in its current position here and in the adjacent closet in the early 20th century or possibly the 1840s renovations. It may also be present behind the modern wall board on the rear wall of room 203. The horizontal boards marked “B” likely date to the late 18th or early 19th century. Whether they are reused or are in their original position has not been determined. Similar boards may be behind the plaster on the west wall of of the chamber. The element marked “C” is the shouldered haunch of the original west corner post. the rest of the post is behind the sheathing.

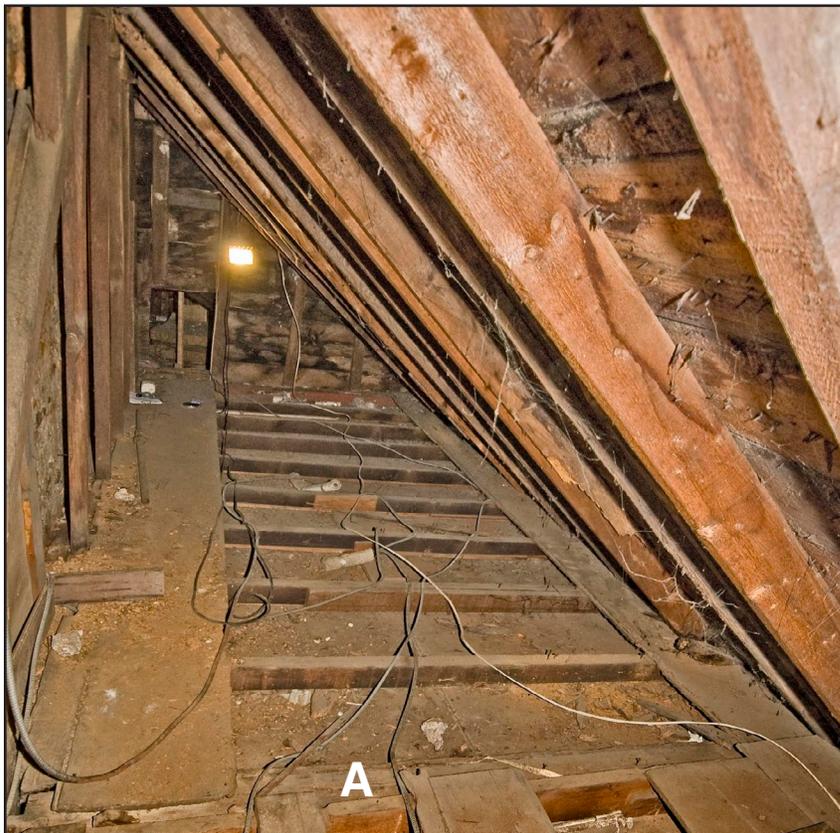
This unfinished space is not currently a functional room and can only be accessed from the ell attic (Photo 32). In the 18th century it was accessed by a door from the back of the parlor chamber and had a finished floor that was one board thick. Several of the floor boards are still in place and are nailed with 18th century wrought nails to the leanto kitchen ceiling joists. It was probably used for storage.

Photo 32: Leanto attic behind parlor chamber looking towards west wall. The remaining floorboards are nailed with 18th century wrought nails and are original along with the floor joists. The beam marked "A" is the leanto chimney girting. The current ceiling in the leanto kitchen is nailed directly to the underside of the floor joists. There was once a small door from the chamber into the leanto attic that would have facilitated its use for storage.

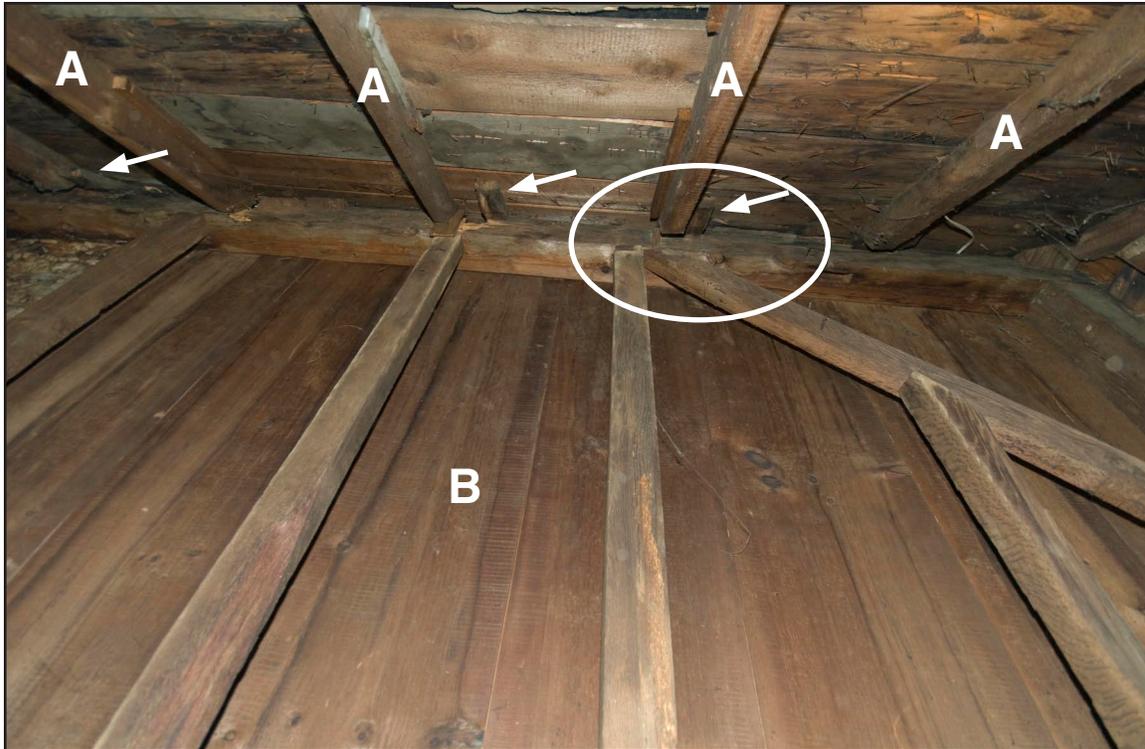
Photo 33: Framing of parlor chamber rear wall in leanto attic. The tails of the main roof rafters can be seen projecting over the top of the roof plate (arrows), with the separate leanto roof rafters (A) next to them. The absence of nail holes in the leanto side of the studs and plate indicates the leanto was built during the original construction of the house. The few random nails near the top of the framing were likely for hanging things. "B" marks the backside of the sheathing in the parlor closet (Room 201A).

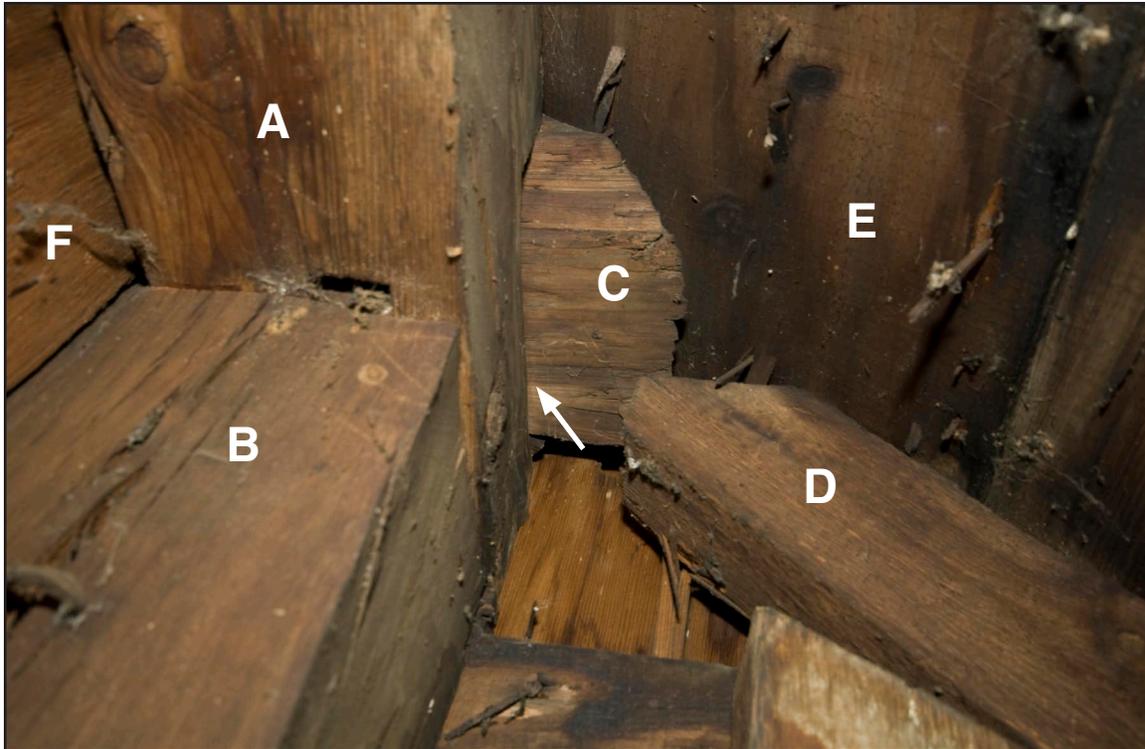
Photo 35: Northwest corner of parlor chamber framing from leanto attic. "A" is the roof plate, "B" is the west rear corner post (partially visible in the chamber bathroom - the post extends down to the first floor as shown in Photos 21 & 22). "C" marks the end of the west wall attic tie beam, "D" is a leanto rafter, "E" is the leanto roof sheathing, and "F" is the backside of the chamber bathroom feather edge sheathing (Photo 30).

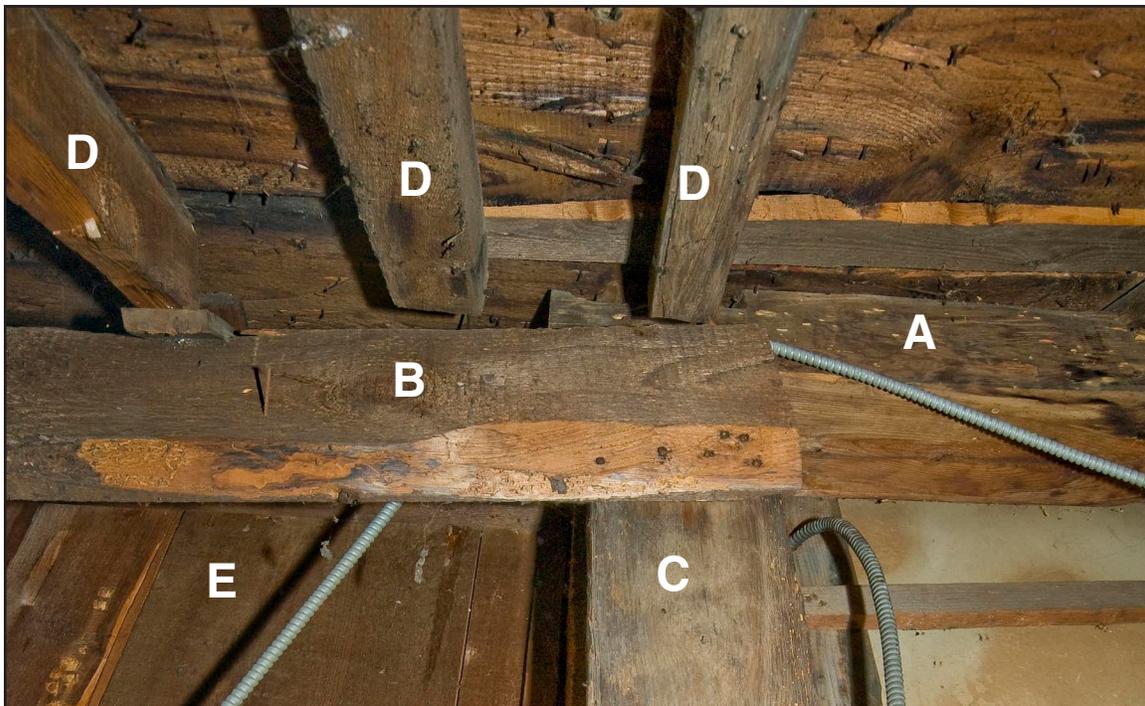
Photo 36: Attic leanto framing behind the northeast chamber (Room 203) at the junction of the original parlor chamber and the original chimney bay at the rear chimney post (C). "A" is the original leanto roof plate that ends just to the left of post "C". "B" is the ledger that was installed in the 1840s to carry the roof rafters in place of plate "A". Leanto rafters are marked "D". The boards "E" may be more feather edged sheathing, and are currently covered by wallboard at the rear wall of the northeast chamber.
