HISTORIC ARCHITECTURE ASSESSMENT REPORT

THE WILLIAM BUTTERS II HOUSE

WILMINGTON HISTORICAL COMMISSION

DECEMBER 4, 2007

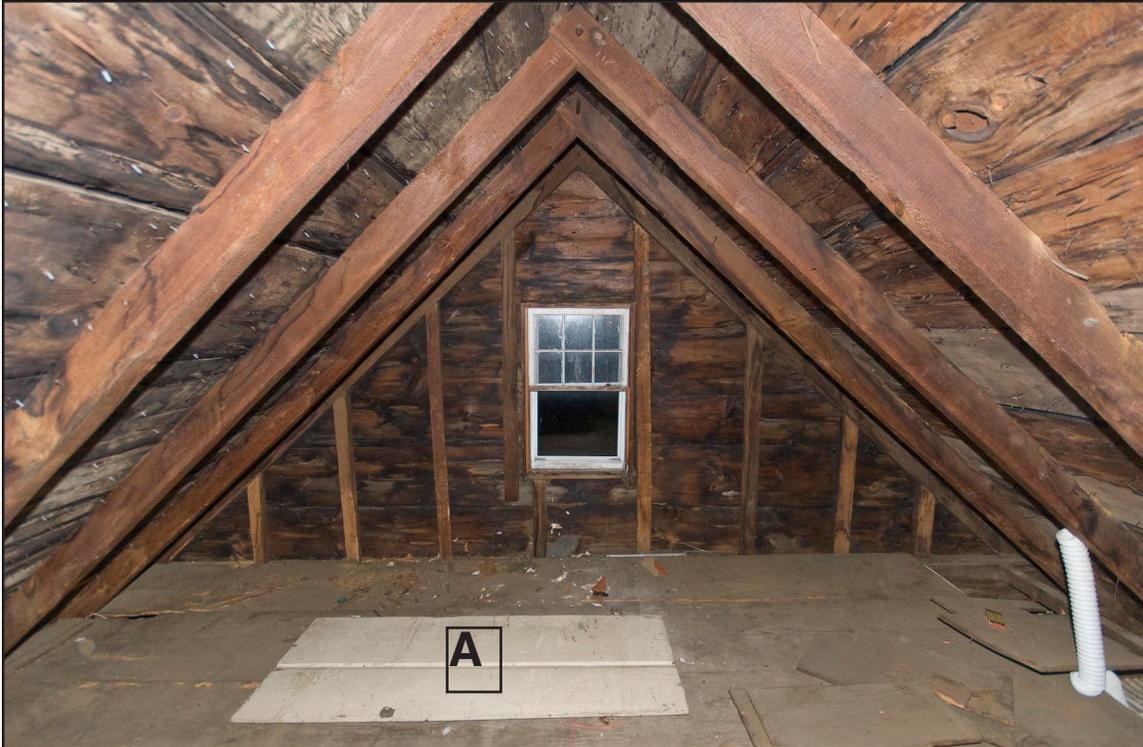
This section of the roof is framed with 8 pairs of common 3" x 5" pine rafters spaced approximately 27" on centers (Photo 37). There is no ridge board. The rafters are joined at the ridge with tightly formed pegged half-lap joints. The rafter pairs have been numbered 1-8 with incised roman numeral marriage marks (i.e., assembly marks) at the ridge joints (Photo 38). They have been installed in consecutive order starting with the west end, except for pair #8 which is

Photo 37: Main attic above parlor chamber looking towards west wall showing original common rafters and original flooring. The studs on the west end wall are also all original except the one at the left side of the window which has been moved to accommodate the current window. The white boards on the floor (A) are 18th century feather edged sheathing that has been made into a door, presumably for somewhere within the house.

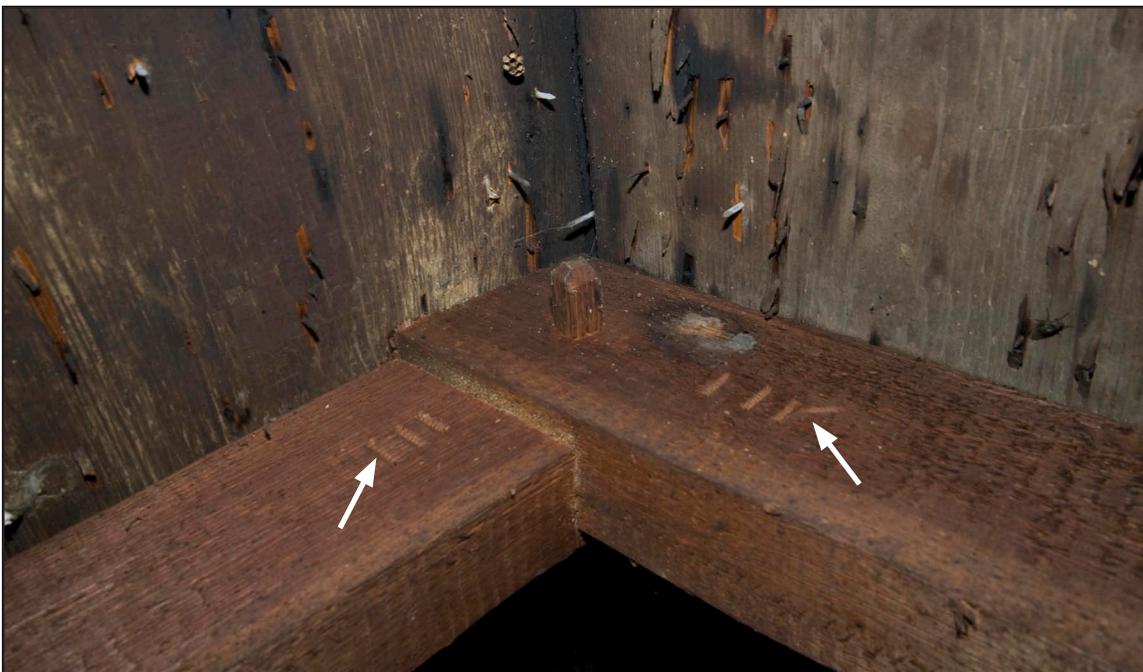
Photo 38: Original attic rafter pair at ridge showing numerical marriage marks "III". The tick on the right hand mark is to distinguish the right rafter from the left rafter. As discussed in the text, rafter pair # VIII has been installed out of sequence after # III, but all others are in sequence. This is probably a construction error rather than an indication of reuse from another building.

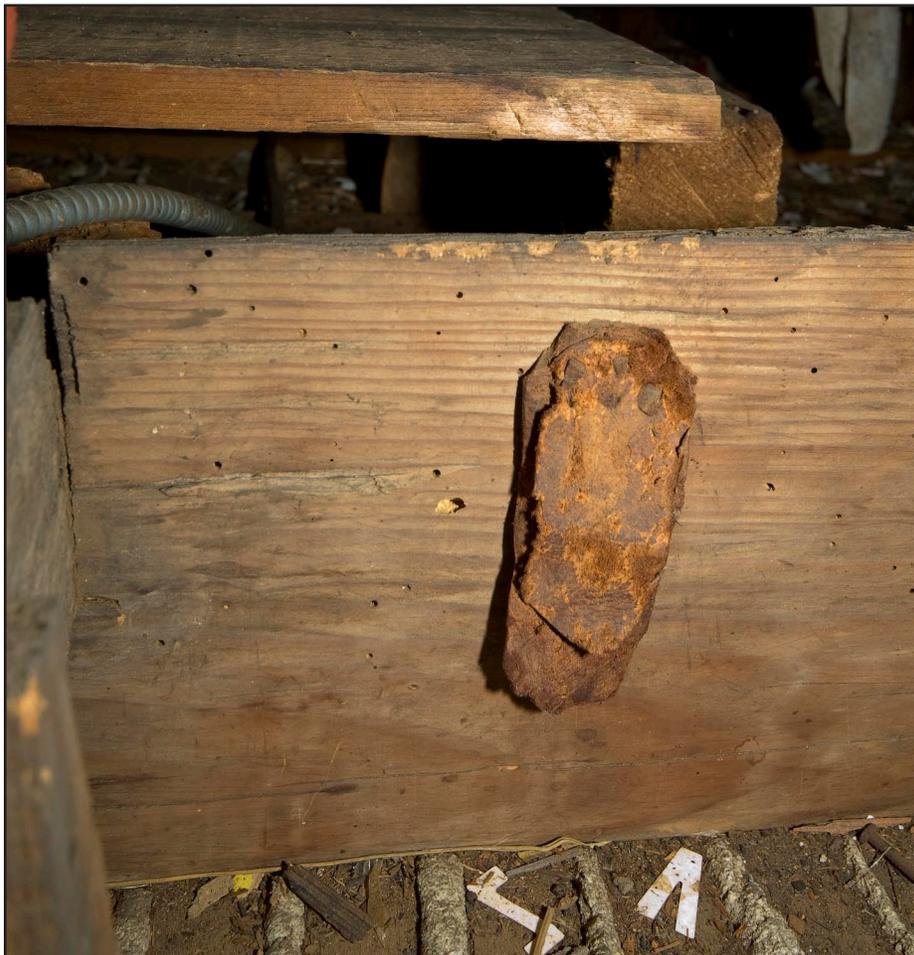
There are no nail holes or plaster stains on the joists to indicate there was an earlier plaster ceiling in the chamber. A few random pieces of leather fastened with 18th century wrought nails were observed on the side of the chimney girt, but they likely were for some other unknown function (Photo 42). There is no whitewash on any of the framing or the undersides of floor boards. Apparently the ceiling framing was exposed but never painted right up to the 1840s. The detailing of the framing is the same as the first floor ceiling with beads on the edges of the tie beams and roof plates (now partially shaved off), and narrow chamfers on the edges of the joists.

Photo 42: Detail of piece of leather attached to attic tie beam with 18th century wrought nails. The function of this is not known. Several were observed, but not enough to suggest they were hangers for an 18th century ceiling in the parlor chamber.

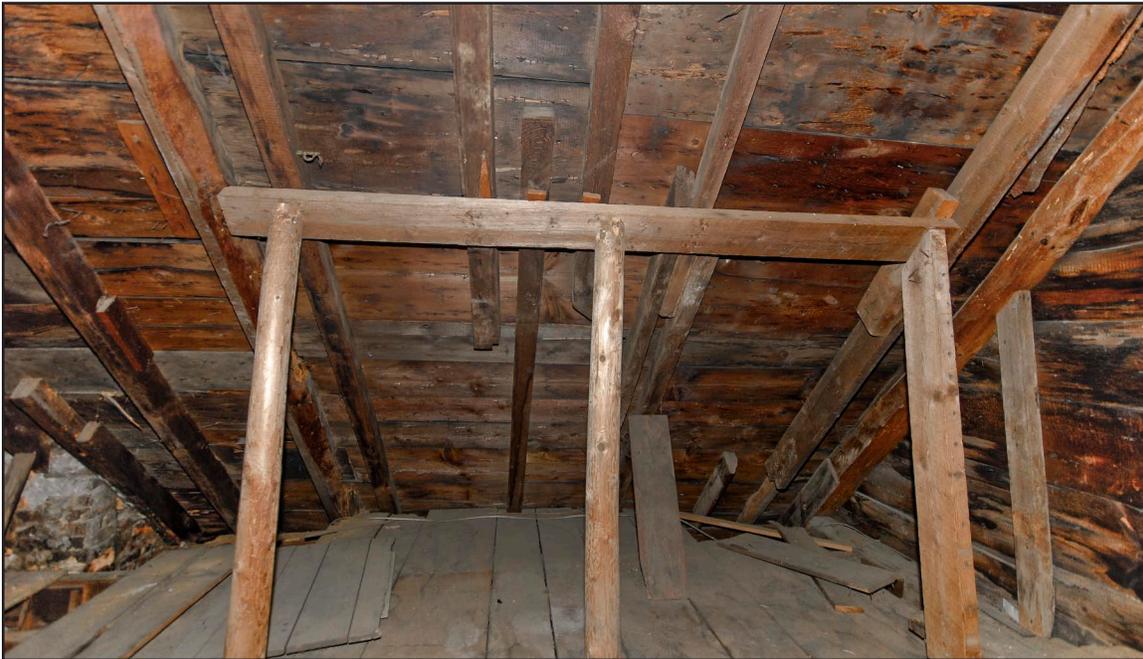
Both the roof and floor framing within the original chimney bay have been extensively reworked, probably in the 1840s alterations, and there is also a variety of more recent make shift repairs. The roof framing is a variety of reused early framing and added pieces of varying lengths and species (Photo 43). One of the short pieces in the rear pitch is oak with a small scratch molding worked into its edge suggesting it may be a reused early door or window frame (Photo 44). In some cases the rafter pairs do not meet at the roof, and in others the rafters are short pieces that have been crudely sisted to make up the proper length. Instead of a conventional plate at the junction with the leanto attic, there is a 2' x 10" ledger spanning from the chimney tie beam to the east end wall (Photo 36). Several rafters extend well over the ledger and terminate in the middle of the leanto roof. Supplementary braces have been added under both the front and back roof pitches, apparently to correct roof sags (Photo 43). These braces bear on the floor boards and joists which may become overloaded from the added roof load.

Photo 43: Attic roof framing on north side over the northeast room (i.e., the original chimney bay) showing the shoring added in the 1970s to reinforce the roof framing. The feet of the braces bear directly on the floor boards and perhaps a floor joist, which may not have sufficient strength to carry added roof loads. The roof rafters in this section are a hodge-podge of reused and discontinuous timbers. New continuous roof rafters should be added and the shoring reworked to have proper bearing (if it is still needed). Similar shoring and discontinuous rafters are also present of the south side of the chimney bay.

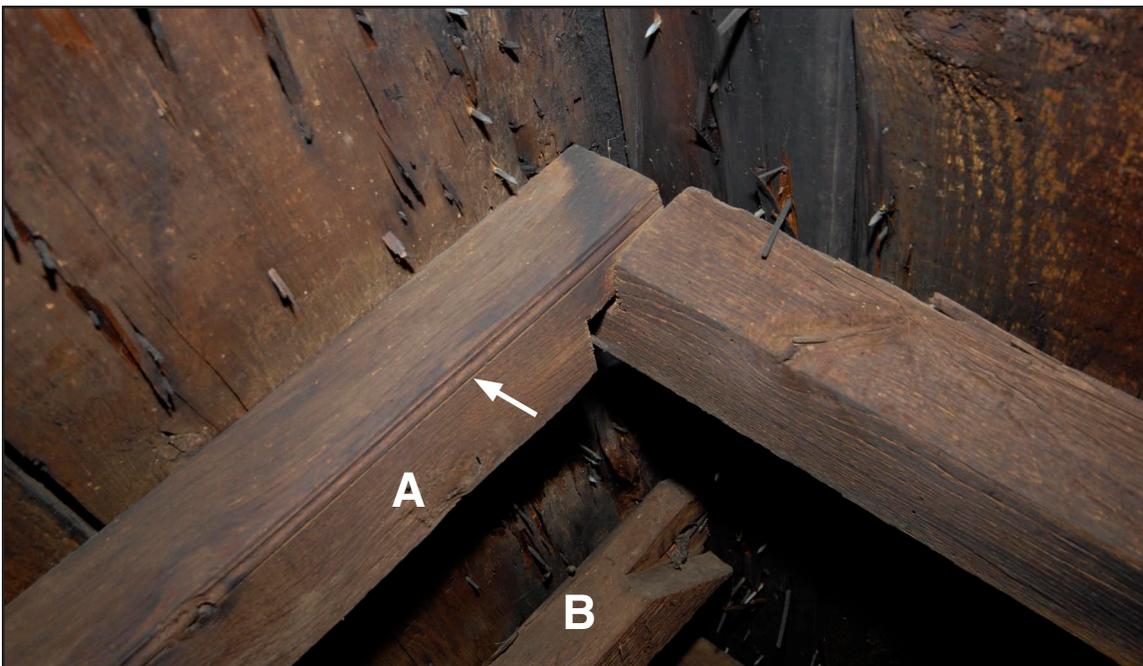
Photo 44: Ridge of attic at original chimney bay. "A" is a piece of dressed oak with a molded edge (arrow) suggesting it may be a piece of a first period door or window frame that was reused as a rafter in the 1840s alterations. It should be retained and preserved. The piece marked "B" is a former rafter with its half lap joint turned the wrong way.

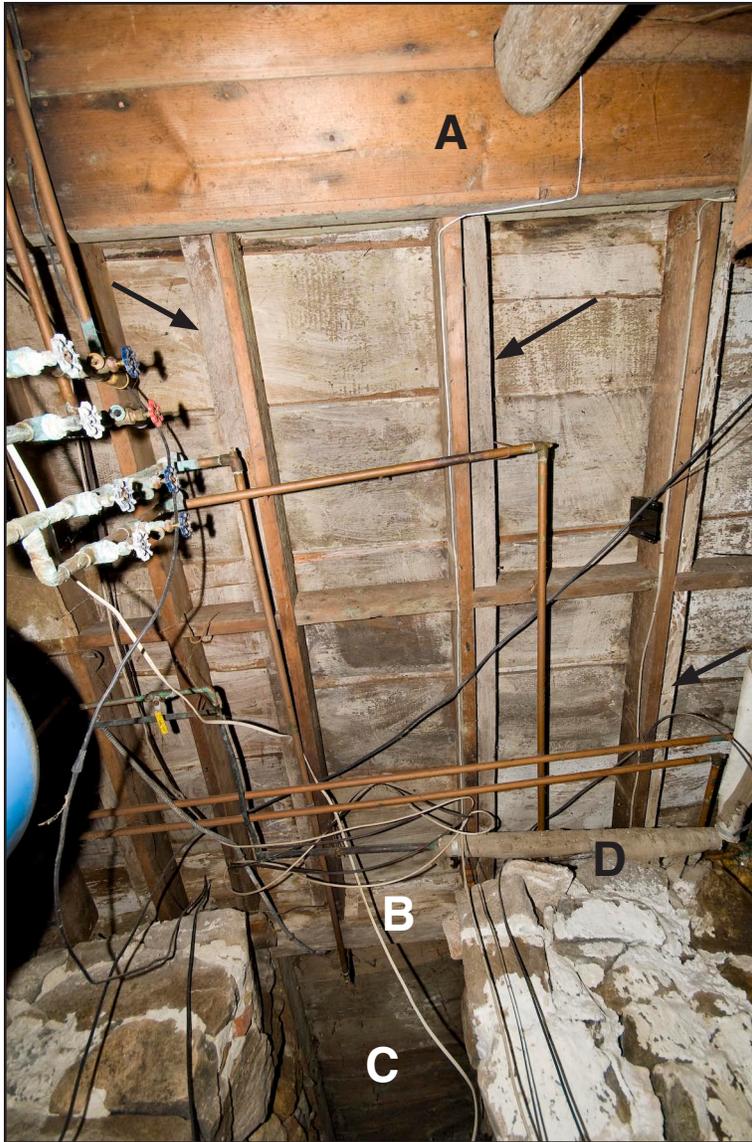
Like most first period houses, the cellar does not extend under the entire house. In this case it is under the footprint of the original west parlor, with a narrow slot extending easterly under the front stairs (Photo 47). This slot originally housed a stair from either the front entry or, more likely, the former east room down to the cellar. Assuming a two room plan, the east room would have been the hall (i.e., kitchen) with the stairs leading from it to the cellar which would have been used for storing food. There is no cellar under what is now the northeast room because the

The framing for the floor of the parlor is visible in the cellar. It consists of a 12" wide transverse (front to back) summerbeam with 3" x 4" joists spanning east-west to the chimney girt on the east and the west wall sill on the west side (Photo 47). The summer beam was framed into the original front sill and the rear sill located under the rear wall between the original parlor and the leanto. Its joint to the front sill has been cut due to past rot and a cedar post placed under it. There has been extensive deterioration to many of the joists and the summer beam from insects and dampness over the years. As a consequence most of the original joists have been sistered, the summer beam has been boxed in below the joists and on its underside, and a number of supplemental posts have been added. While these repairs have been somewhat make-do, the parlor floor does not currently exhibit excessive deflection, and its uneven level seems mostly due to the sagging of the front wall over the added 1840s sill and foundation.

Photo 47: Cellar framing under the original parlor looking towards the east wall of the cellar. "A" marks the summer beam that has been enclosed with modern boards, "B" marks the chimney girt, and "C" indicates the opening in the foundation that originally held the stairs to the cellar. The arrows point to original parlor floor joists that have been sistered with modern 2x4s to reinforce the floor framing. "D" indicates some pipe insulation that should be tested for the presence of hazardous materials by a hazardous materials professional.

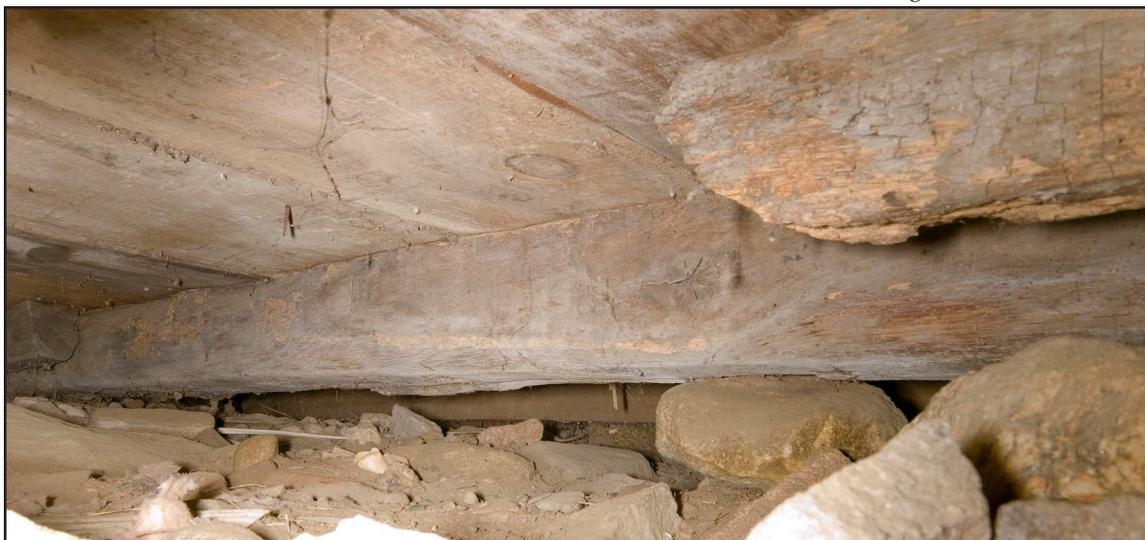
There is very little visual access to the framing over the crawl spaces. A small amount of the framing under the front entry floor can be seen from the former stair slot (Photo 48). It appears to be heavy joists running east-west that are primarily supported on random piles of stone. They do not appear to be framed into the east sill or the chimney girt. A very small portion of the leanto floor framing is visible where the rear cellar wall is penetrated by the waste pipe. It also has heavy joists that are framed into the sill under the parlor rear wall, and appear to be sitting in the dirt as they head towards the rear of the leanto. As the leanto rear sill seems to have rotted completely away in the one spot we checked it, the joists probably do not have a positive connection with the rear leanto wall.

Photo 48: Shallow crawl space under the front entry hall as photographed from area "C" in photo 47. The joists are larger than the joists under the parlor. They are not continuous from the east sill to the chimney girt, and are supported on stones in the ground.

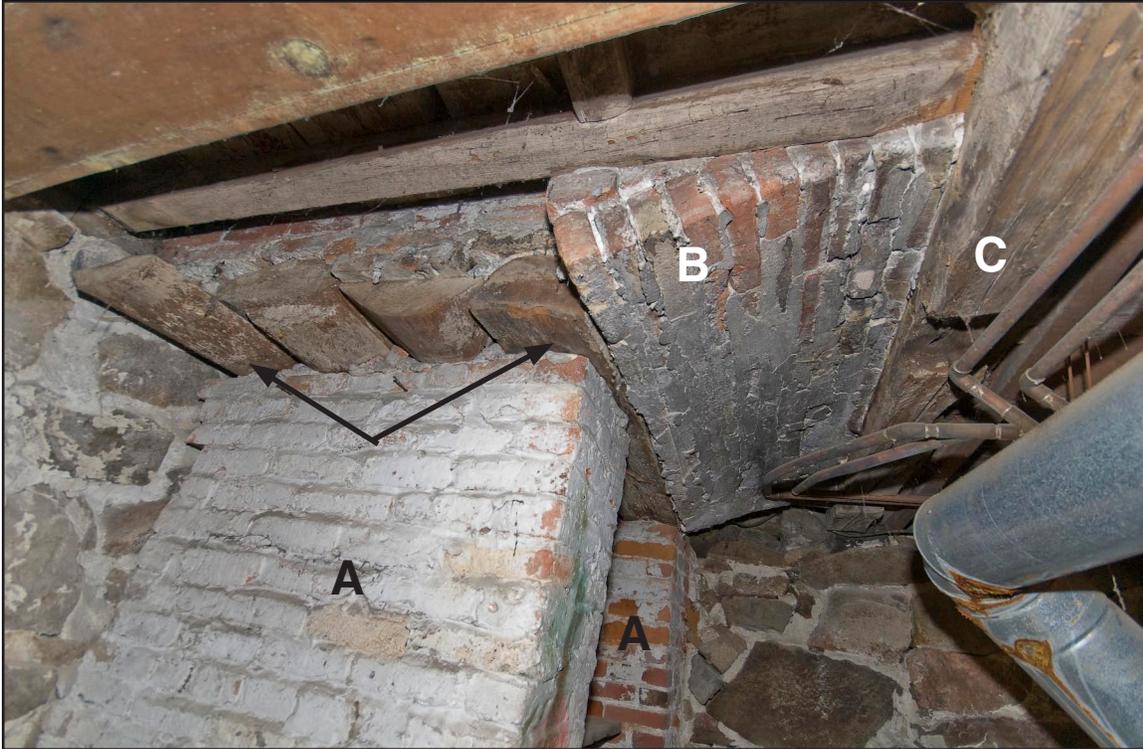
Photo 49: Base for the c. 1840s chimney consists of two brick piers (A) with half logs spanning across the top of the piers to carry the mass of the chimney above the cellar. This construction was often used in the first half of the 19th century instead of a more labor intensive brick arch. The partial arch at “B” is stabilized against the heavy beam “C” to carry the brick hearth in the floor above.
